The Revere Telechron Electric Clock Motor

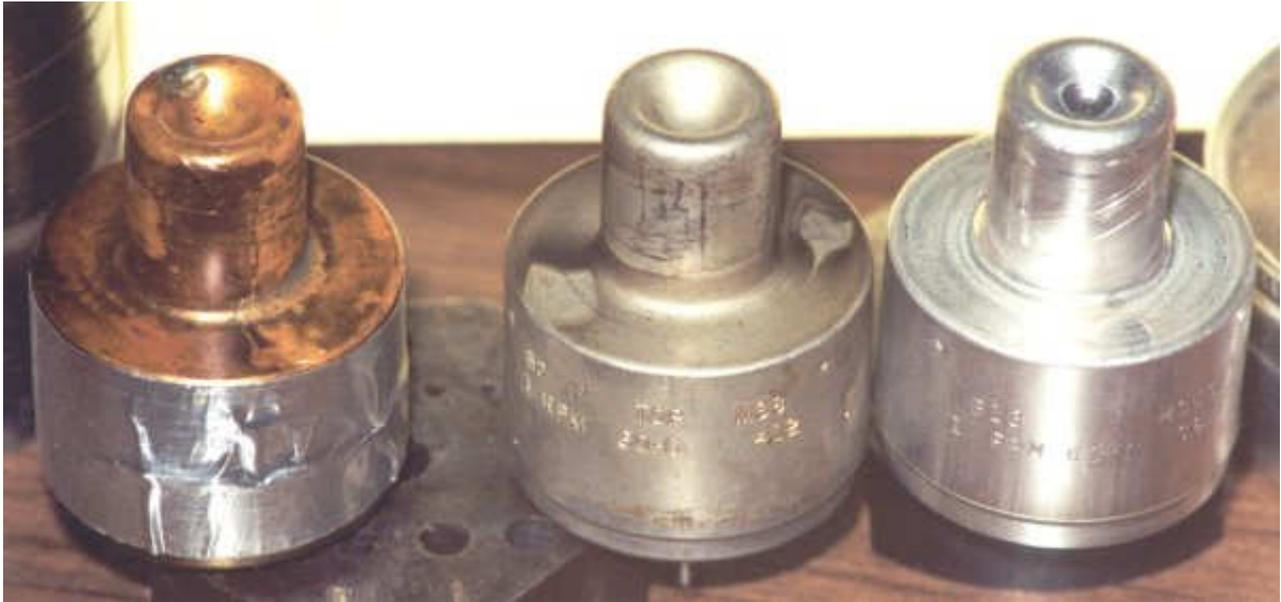
Fig. 1

The exceptionally durable Revere Telechron electric clock is one of several American-made electric chiming clocks, but it differs from the others because of the elegant simplicity of its design and the fact that replacement motors are still available for it. The new motors are not as well made as the old ones, however. As expensive as the new motors have become, you might be curious to know if the motors could be repaired. I was curious to know because the new motors do not appear to last as long. Figure one shows the "B" type motors. The earliest motors have the bronze colour (left). Later motors have the grey colour (middle). The newest motors have an aluminium exterior (right).

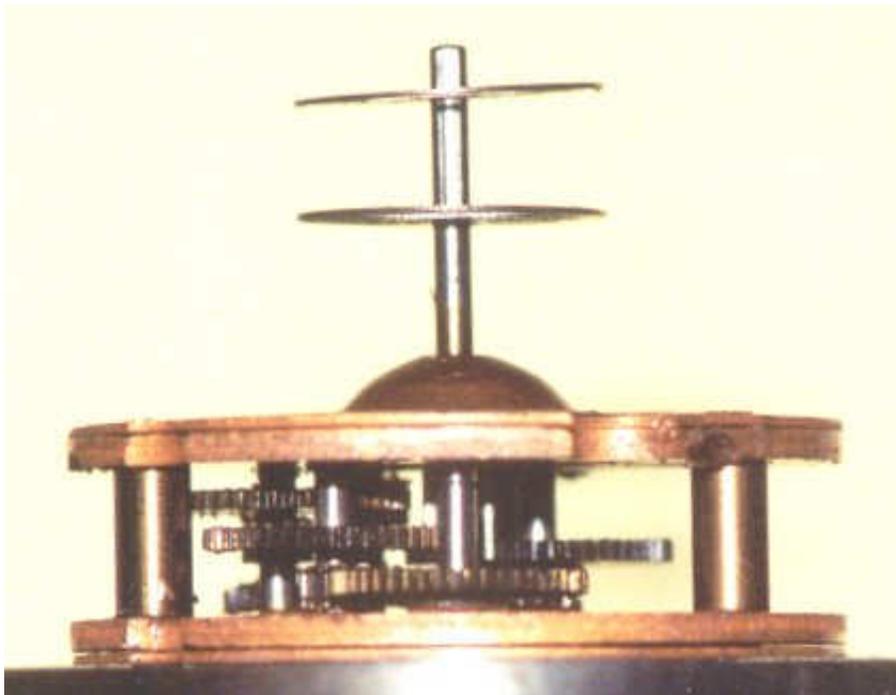
Fig. 4

This particular motor has two rings on the centershaft (the rotor), which is appropriate for clocks without chimes. Clocks with chimes should have four rings, so I added two more rings to the rotor. Notice the bronze plates in Figure four. I have not seen harder bronze anywhere else.

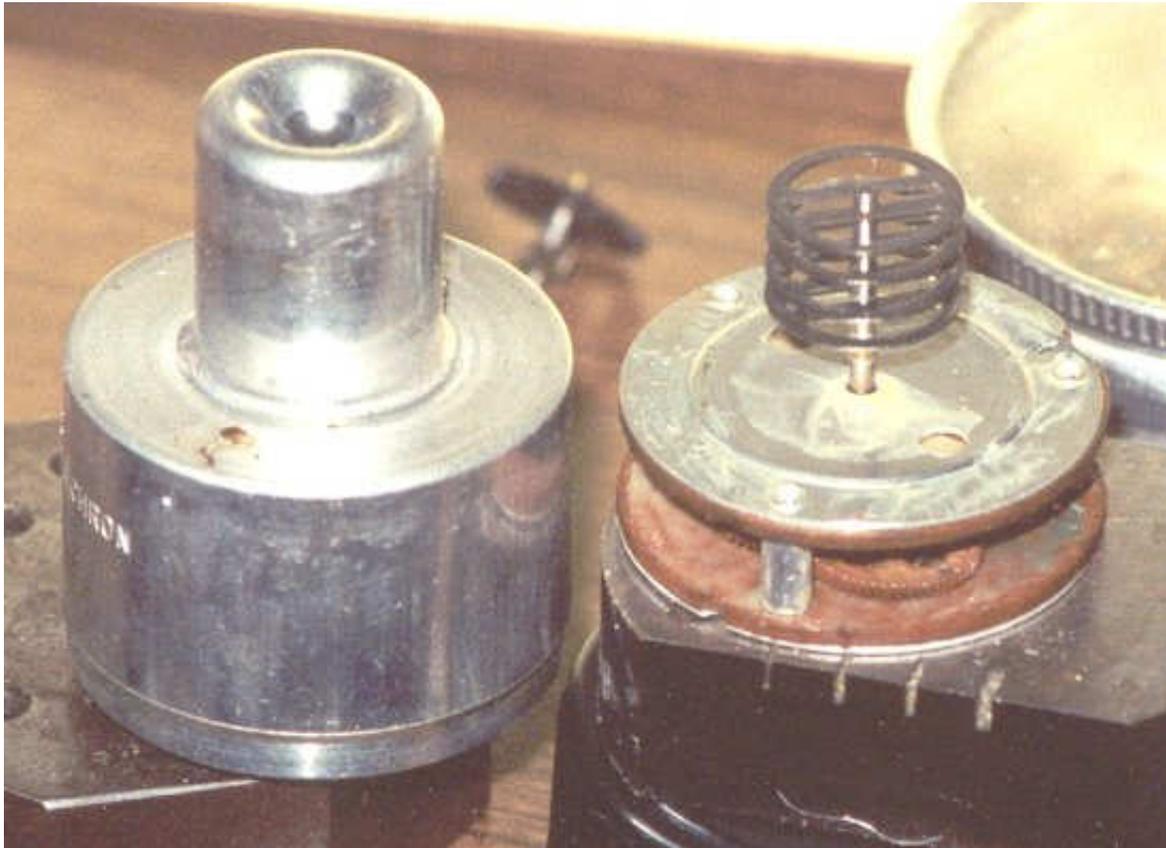
Fig. 5

The new style motor in Figure five does not have bronze plates, but rather a synthetic material. This material probably offers a lower coefficient of friction, but it is not as hard as the bronze. Note that the new motor has four rings. It also has grease instead of the oil used in the older motors (lubrication takes place by capillary action).

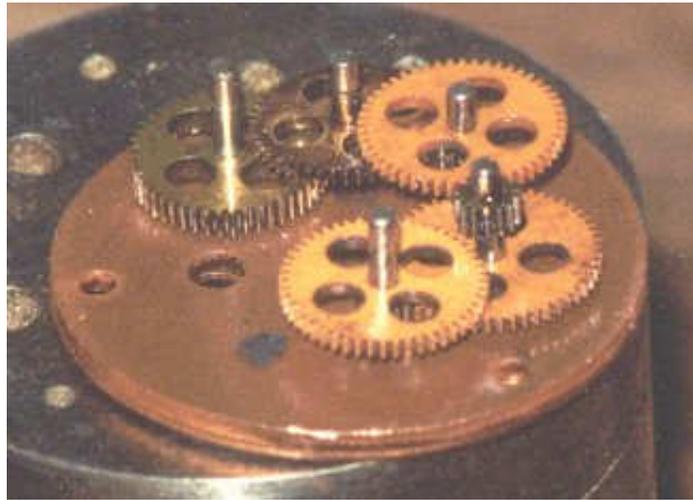
Fig. 6

The bushings in the bronze plates of this particular old motor showed no visible signs of wear, but several of the gears in the train had very badly worn teeth, so I replaced the gear train with gears from another motor (like the motor in the middle of Figure one). The low-torque gears in Figure six were made of a synthetic material, maybe an early form of plastic, commonly used in electric clocks to reduce noise.

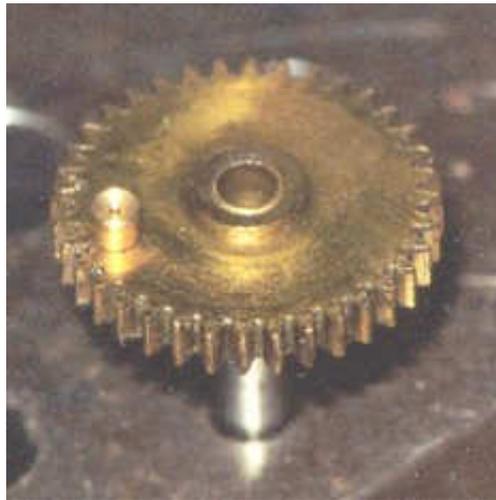
Fig. 7

I disassembled a new style motor to investigate why it was making excessive noise after only four years. There was no visible wear in the gear train, but the rotor's pinion was rubbing against the lower plate. While this appears to be less of a problem with bronze plates, the synthetic material was wearing. To prevent this, I inserted a small piece of brass (a Bergeon bushing, actually: see Figure seven) in the hole of the driver gear, with a small amount of grease to prevent it from falling out during assembly. The excessive noise stopped.
