An Approach to Consider for the Repair of an Altered Strike Mechanism on a Mechanical Clock

The Strike Mechanism (II)

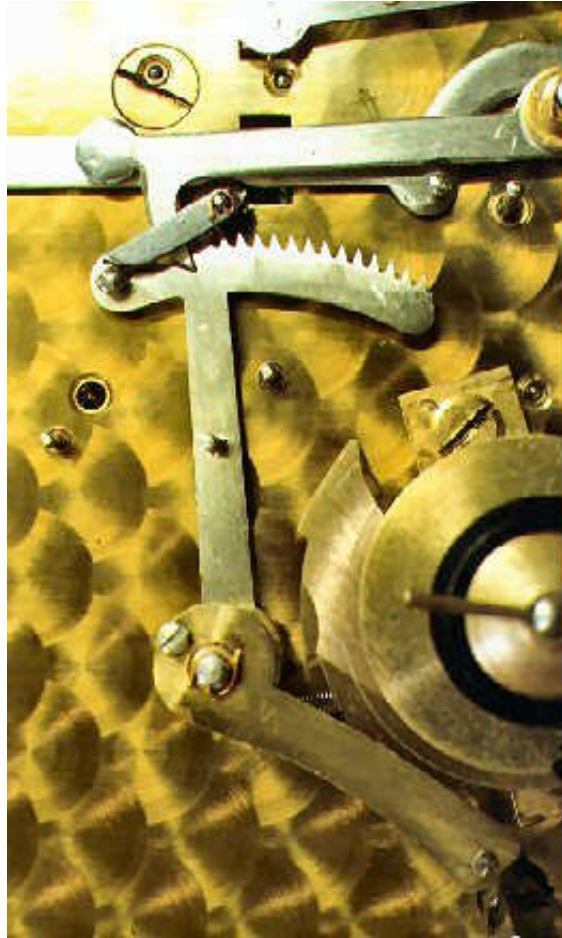
Having read the first part, you will be able to extract more information from this photo of a Herschede strike mechanism.

If you draw a line along the back of the first rack tooth, the line will pass on the right side of the rack post: the angle of the locking face causes a binding effect because the rack must be moved to the right in order to raise the hook lever.

The angle at which the gathering pallet tail meets the rack pin is not at right angles to a line going from the rack post to the rack pin: the gathering pallet tail appears to repel the rack pin. Therefore, the gathering pallet tail must be raised when the rack is moved to the right, which happens when the hook lever is raised.

It should be obvious by now how much force is required to unlock this strike mechanism in order for striking to take place. Activating the strike mechanism should not require a lot of force. This could stop the pendulum.

Since the gathering pallet tail repels the rack pin, the impact of the tail hitting the pin could cause the hook lever to jump up, resulting in continuous striking.

When repairing a clock like this one, I recommend that you **NOT** alter its original design. Doing so could get you into all kinds of trouble. However, being aware of what causes the problems this design has would better enable you to make the repairs necessary to make it work correctly despite its design flaws.
