Miscellaneous Clock Repair Notes:

Chime and Strike Governors in Clocks. Notes About Herschede Electric Clocks. Hammond Electric Clocks.

Hammond Electric Clocks.

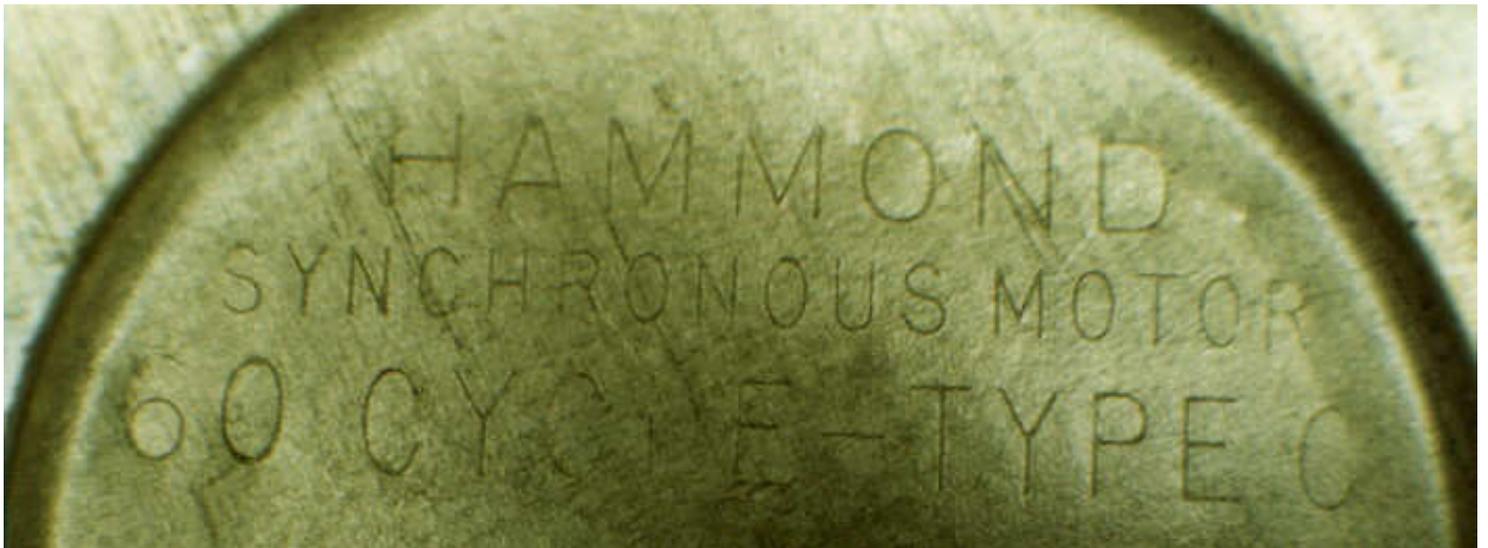
BACK COVER OF MOTOR

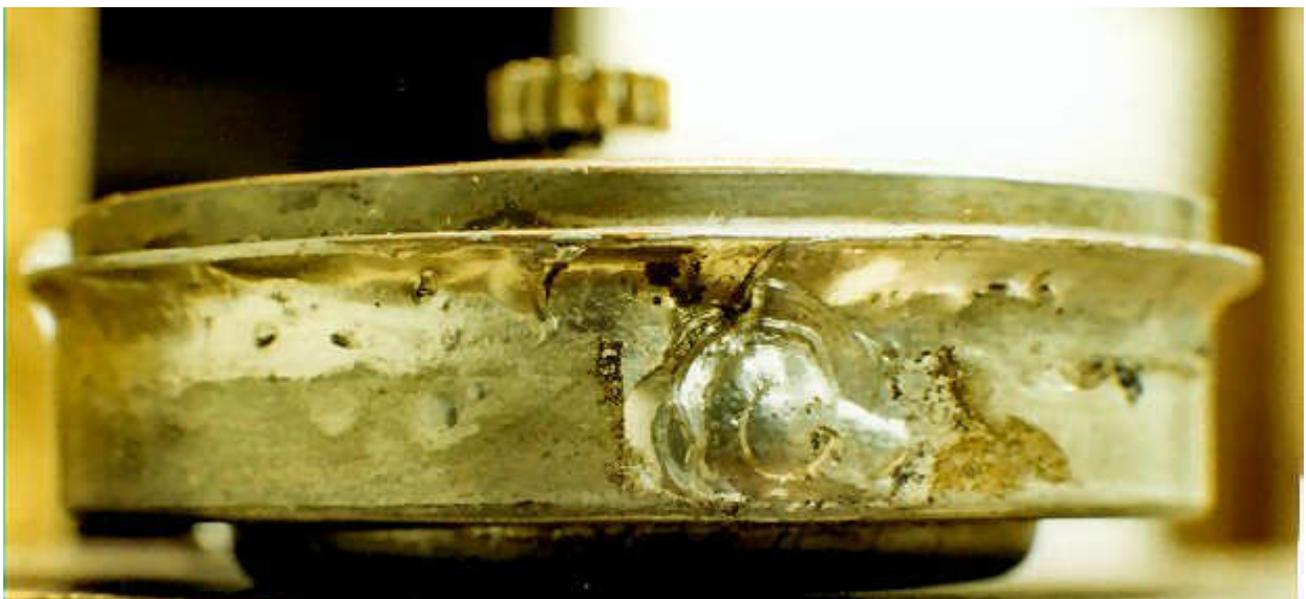
SIDE OF MOTOR BEFORE GRINDING EDGE

I was given one of these clocks and, since it did not run, I took the motor apart because I had nothing to lose. The best way to do this is to place the outermost edge against a stone grinding wheel, all the way around, removing about 1 mm. of circumference (see photos below), and pry it apart with a screwdriver. One side of the case has an extra quantity of solder which covers up a lubrication hole: pry open from the other side. The two brass plates inside are riveted together: grind off the rivets, of which there are four, and pry off the back plate. If you grind off just enough rivet to remove the plate, it would go on friction tight afterwards and this would not come apart by itself. The only thing that seems to go wrong with this motor is that the rotor is relatively heavy and this weight wears out the brass hole until the rotor rubs on the frame just next to it, stopping the clock. To remove the rotor, it is necessary to remove the 2nd gear with a staking tool or a punch. Clean all the parts thoroughly: automotive brake cleaner in a spray can works very well because it leaves no residue and is a very powerful solvent. Install a bushing at each end of the rotor, lubricate with a quality oil formulated for electric motors. You could mix a small amount of moly graphite

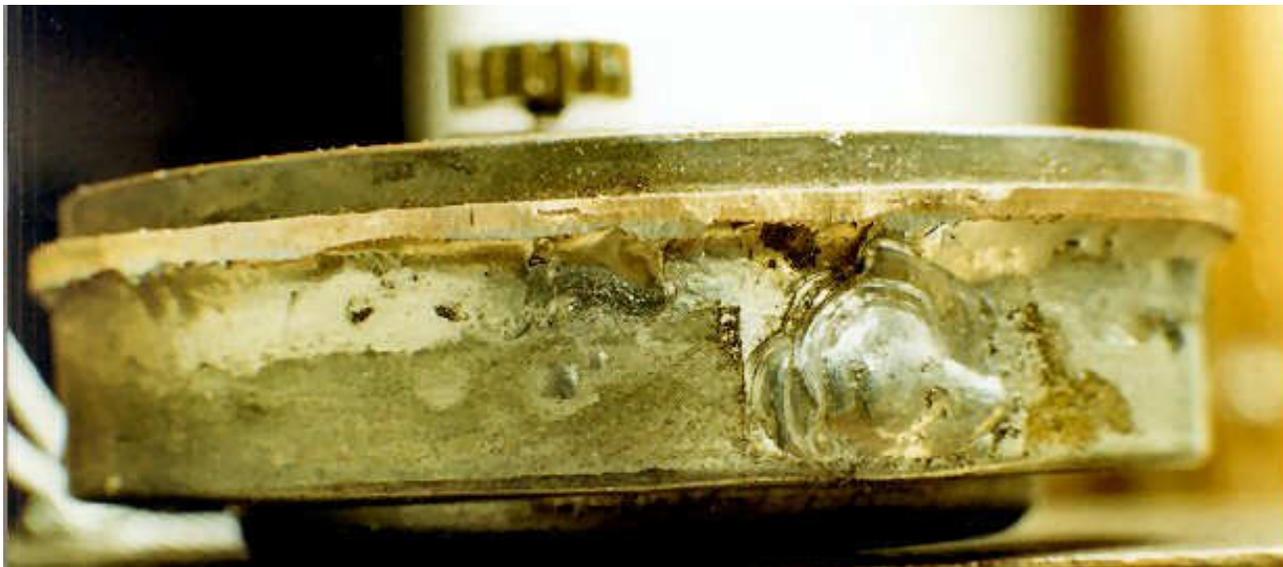
SIDE OF MOTOR AFTER GRINDING EDGE

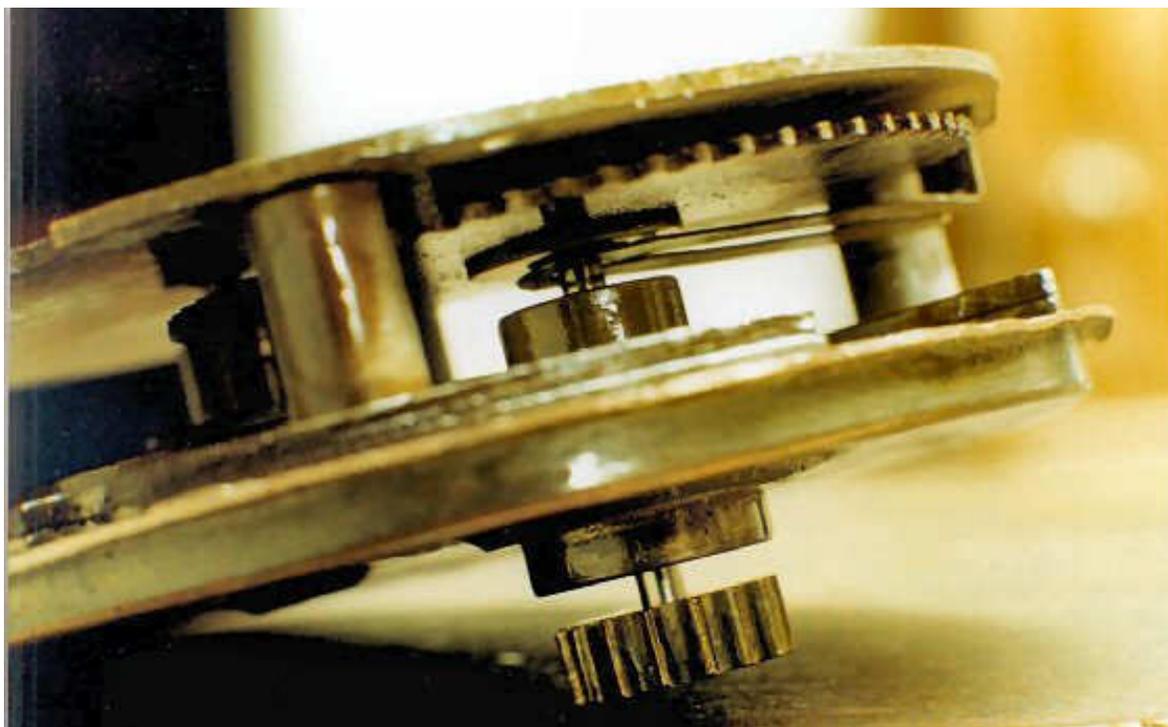
VIEW OF 2ND WHEEL INSIDE MOTOR

grease with the oil (about 5%) for better results. Lubricate all the teeth of the bakelite (?) 2nd gear next to the rotor and its post. Be careful because these teeth are very fragile. Install a small steel washer between the 2nd wheel and the back plate to reduce friction because of wear in this area. Press the brass plates together again, stake the 2nd gear together again as it was, and place the exterior cover on again in the same position as before. I sealed the exterior with a piece of woven glass fabric insulating tape, but a piece of heat-resistant electrical insulating tape would work nicely.

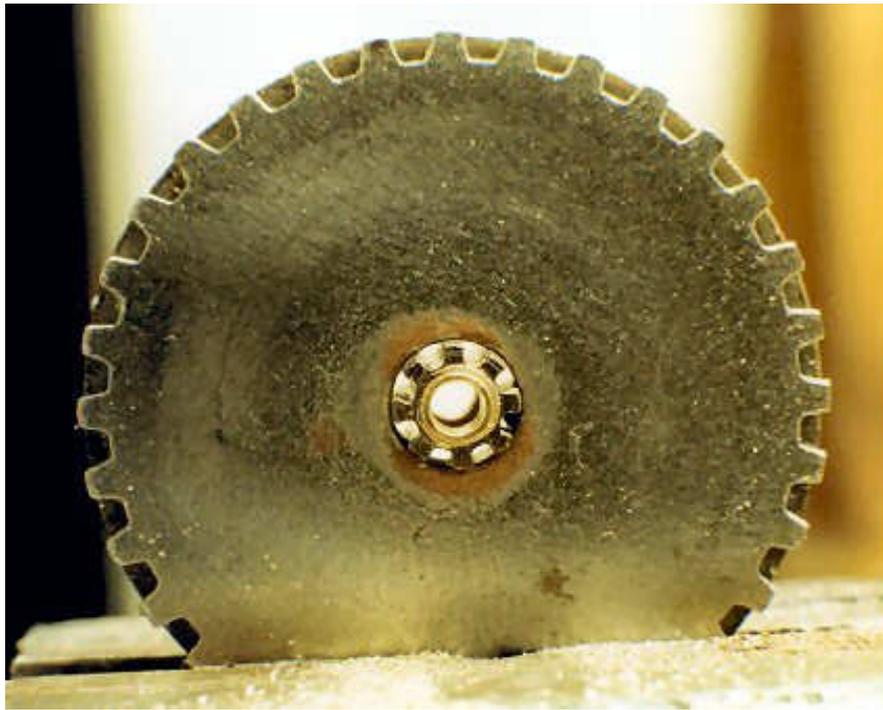
ROTOR WITH BUSHINGS INSTALLED

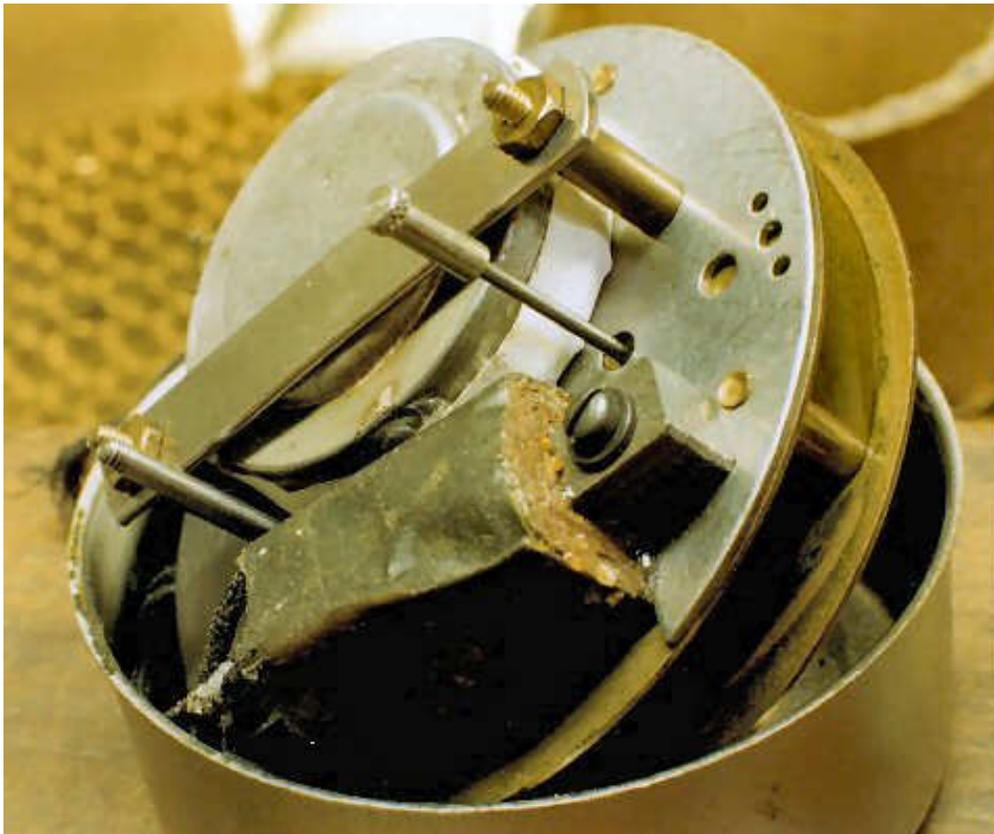
MOTOR INSTALLED IN CLOCK
