AN APPROACH FOR THE DIAGNOSIS OF A WORN BRASS BUSHING IN A MECHANICAL CLOCK

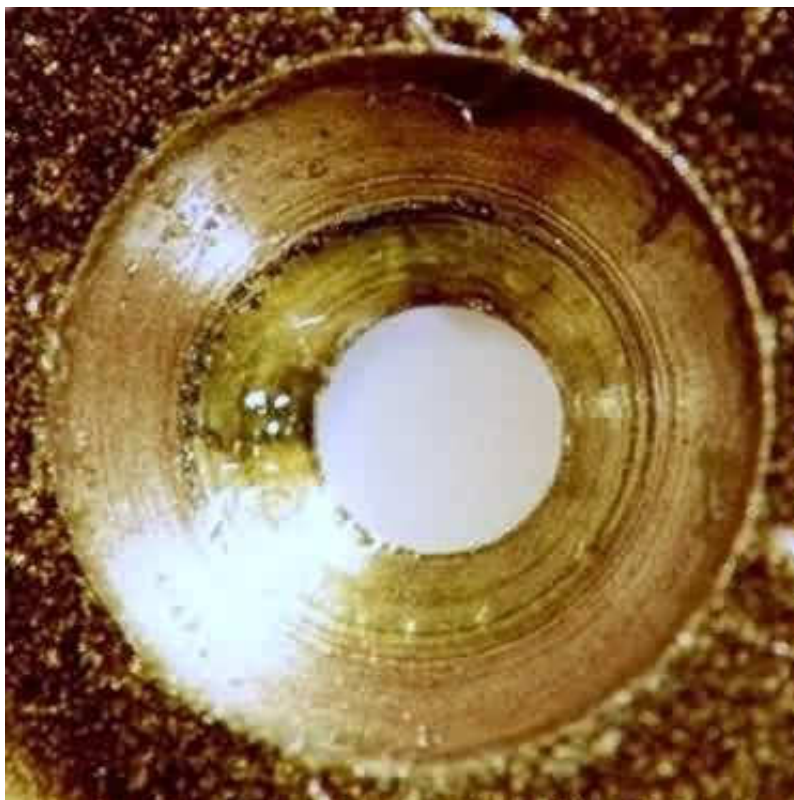
Of considerably greater challenge is the diagnosis of the bushing that seems to be in good condition in every visible way. This bushing looks round under inspection. The pivot has equal side-shake in all directions. There is virtually no black oil paste, but rather a light green jelly, (deteriorated oil, but without brass powder), or no oil. These bushings can easily be misdiagnosed, risking a come back.

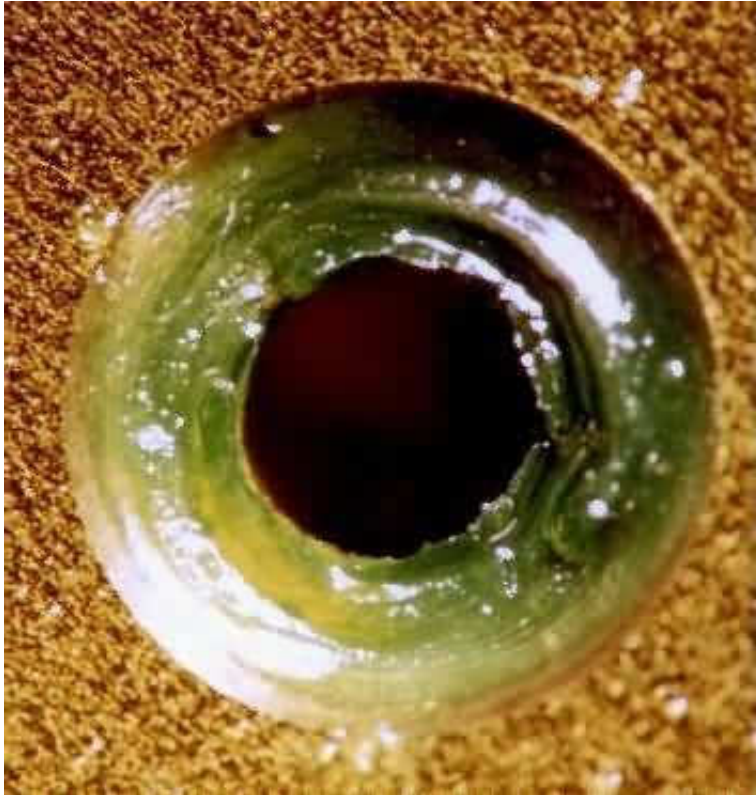
Compare the clean-looking bushing with these very obvious examples. Few bushings show the conditions described above as obviously as these. The first bushing has a lot of "green jelly" that could cause drag.

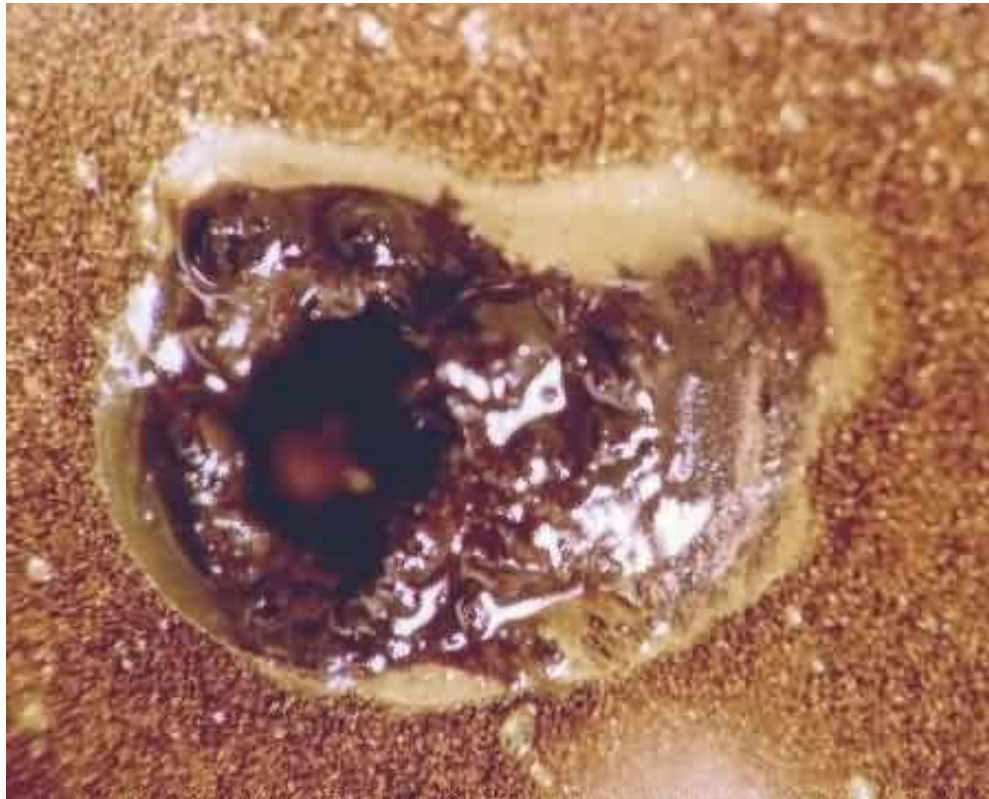
The second bushing has a large amount of black oil paste.

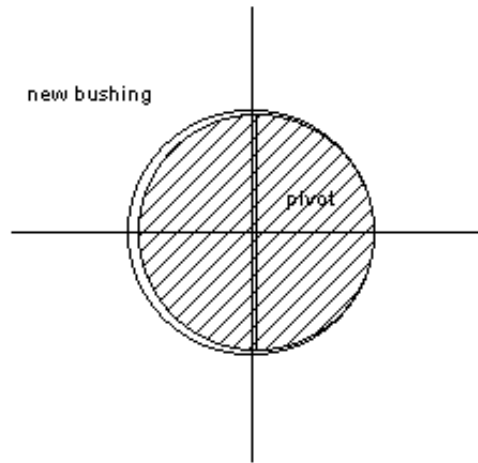
This test requires us to visualize the behavior of the pivot in the bushing. The theoretically perfect pivot is a perfectly parallel cylindrical shaft polished to a mirror finish. The brass bushing is a parallel cylindrical hole with a mirror finish. The bushing hole should be slightly larger in diameter than the diameter of the pivot so that the pivot can rotate freely inside the bushing. Let us imagine, for example, that the preceding gear is located directly below and it rotates in a clockwise direction.

Therefore, the pivot rubs on the right side of the bushing as it rotates. The surface area of the bushing in contact with the rotating pivot is small because the diameter of the hole is larger than the diameter of the pivot. As the bushing wears, the area in contact with the pivot increases dramatically: a maximum of fifty percent of the surface area of the pivot can rub against the bushing.

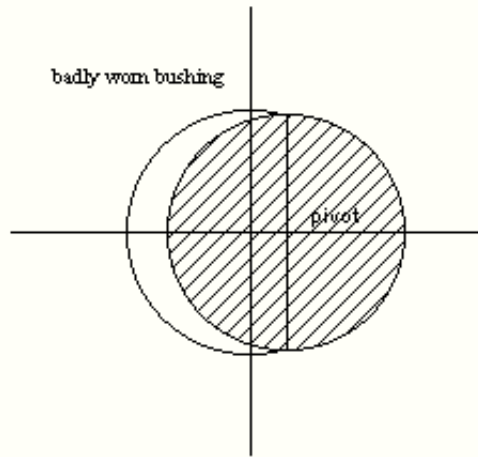
However, it is not the increase in surface area that causes the increase in friction as the surfaces wear, because friction is independent of the area upon which a force is acting. The friction is dependent upon the magnitude of the force acting on the pivot, (pushing it to the right), and the yield pressure of the metals, a measure of the force the metal particle irregularities in a unit area of surface can support before being crushed down. So, all else being equal, the friction taking place in the new bushing is the same as the friction taking place in a worn bushing that has been cleaned, (contrary to most people's expectations), unless the surfaces have become rough. Now think about the foreign particle becoming embedded in the brass that scratches the pivot, as described in the rough bushing test. The rougher pivot scratches the brass. The result is further contamination of the oil in the bushing, which turns from a slick liquid to an abrasive paste of foreign particles, brass and steel powders, with a texture similar to toothpaste. In the new bushing, the hole is larger than the pivot. There is room for the paste to be pushed out of the way. In a badly worn bushing, the hole the pivot has dug for itself is now effectively the same size as the pivot diameter. The paste is thicker than the oil was because of the contaminating particles in it. Since the pivot and the worn portion of the bushing hole are the same size, the paste causes binding. Now consider the same scenario with a dry bushing, or without enough oil to form a paste. If both the pivot and hole surfaces are rough, the roughness could cause a small shift to one side, (much the same way the front tire of a bicycle shifts to one side a little when it rides over a pebble). If this shift pulls the pivot shoulder against the brass plate, a considerable increase in friction or even binding could occur. This would sometimes happen and sometimes not, making its behavior appear to be random. The broach test is also simple, once the logic behind it is understood. Put a cutting broach into the bushing hole to be tested. Turning with a FEATHER-LIGHT TOUCH, determine whether there is any binding of the broach.

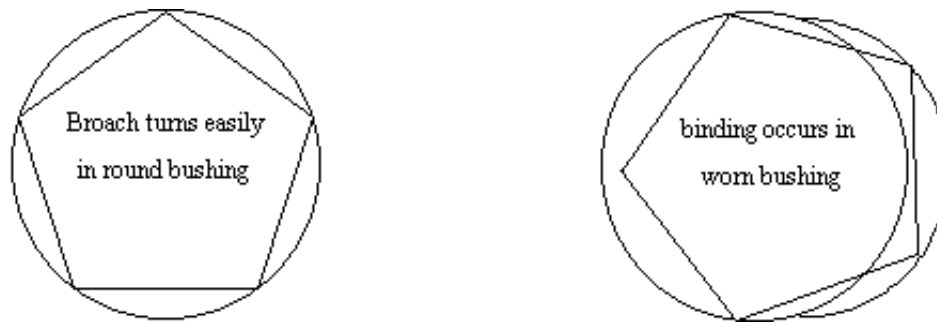
If the hole is anything but perfectly round, the broach will get stuck in the hole and your feather-light grip will slip. I emphasize feather-light touch because if slightly too much force is used, the broach will cut right through the imperfection in the hole and the latter would not be noticed. Also, too much force can result in too much brass being cut, so a bushing would have to be installed. If the broach gets stuck and your fingers slip, the bushing needs to be investigated further. If the broach does not get stuck, then only a minimal amount of brass, maybe 0.02 mm. thick, would be removed. This would expose a fresh, uncontaminated layer of brass, thus serving to recondition the bushing.

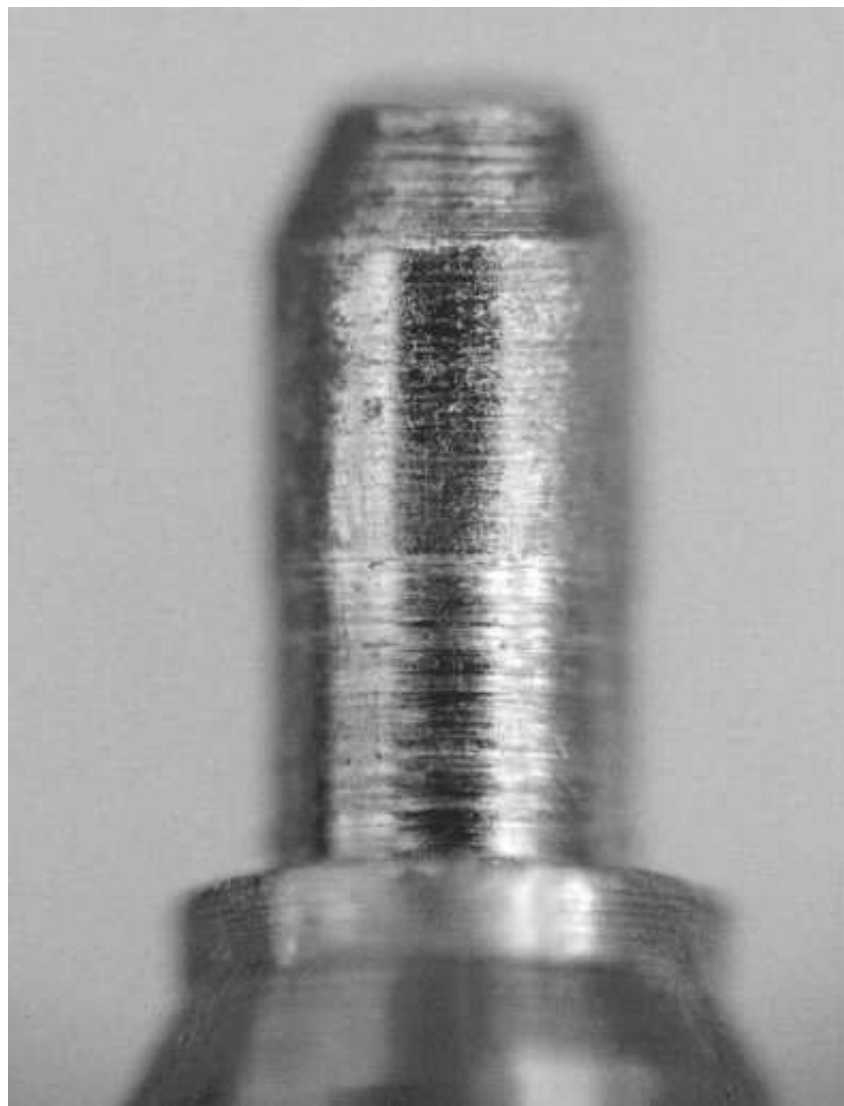
Below is a typically lightly-worn pivot. This photo shows much more detail than you are likely to see with your loupe at the bench, even with a 10x loupe. It would probably look alright and also pass the finger-nail test if the clockmaker were not paying particularly close attention. This photo also shows that the unworn part of the pivot does not have a perfect mirror finish, as is typical of mass-produced clocks.
