AN APPROACH FOR THE DIAGNOSIS OF A WORN BRASS BUSHING IN A MECHANICAL CLOCK

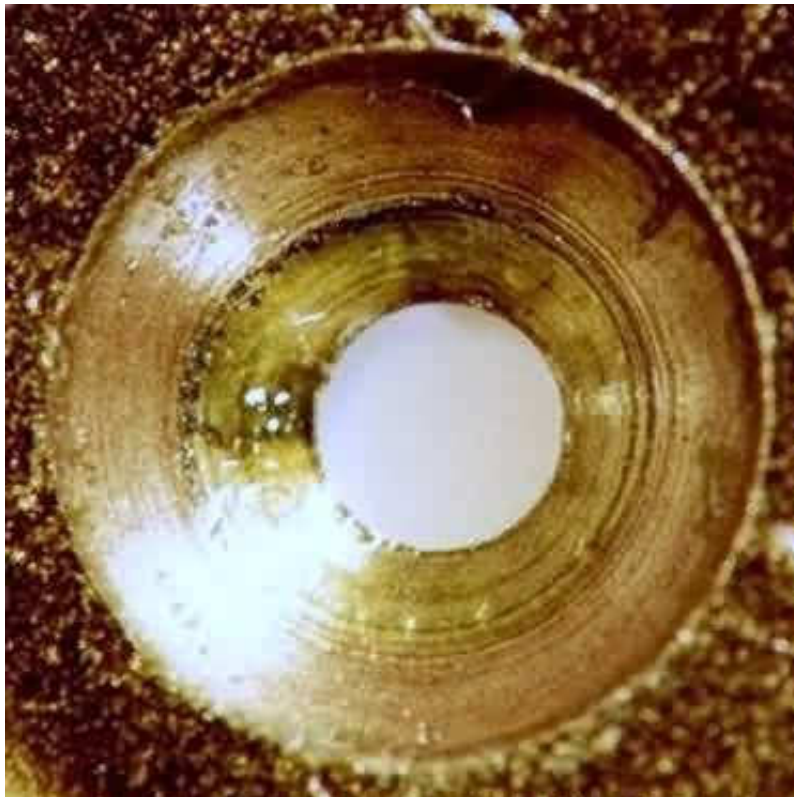
Of considerably greater challenge is the diagnosis of the bushing that seems to be in good condition in every visible way. This bushing looks round under inspection. The pivot has equal side-shake in all directions. There is virtually no black oil paste, but rather a light green jelly, (deteriorated oil, but without brass powder), or no oil. These bushings can easily be misdiagnosed, risking a come back.

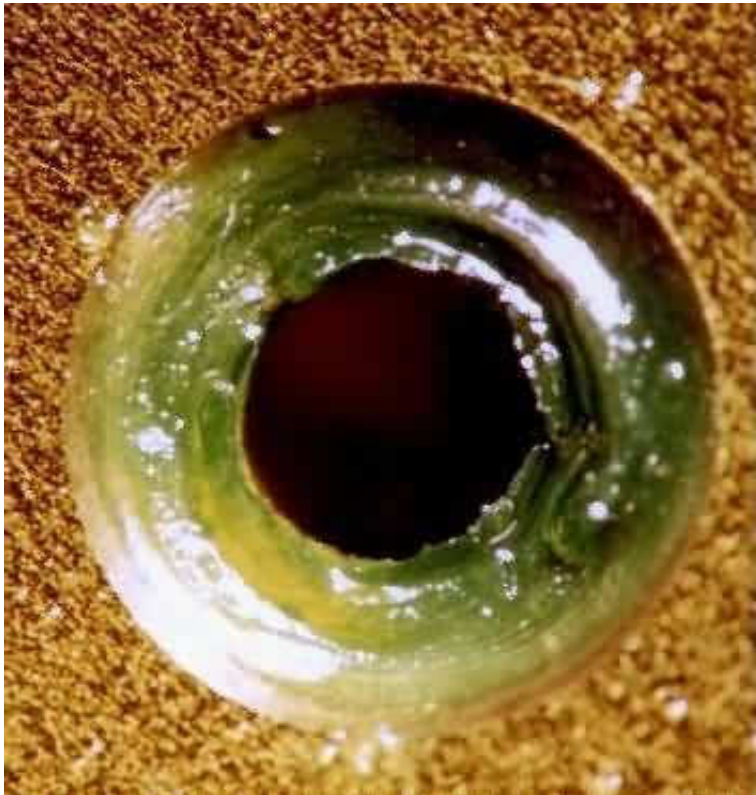
Compare the clean-looking bushing with these very obvious examples. Few bushings show the conditions described above as obviously as these. The first bushing has a lot of "green jelly" that could cause drag.

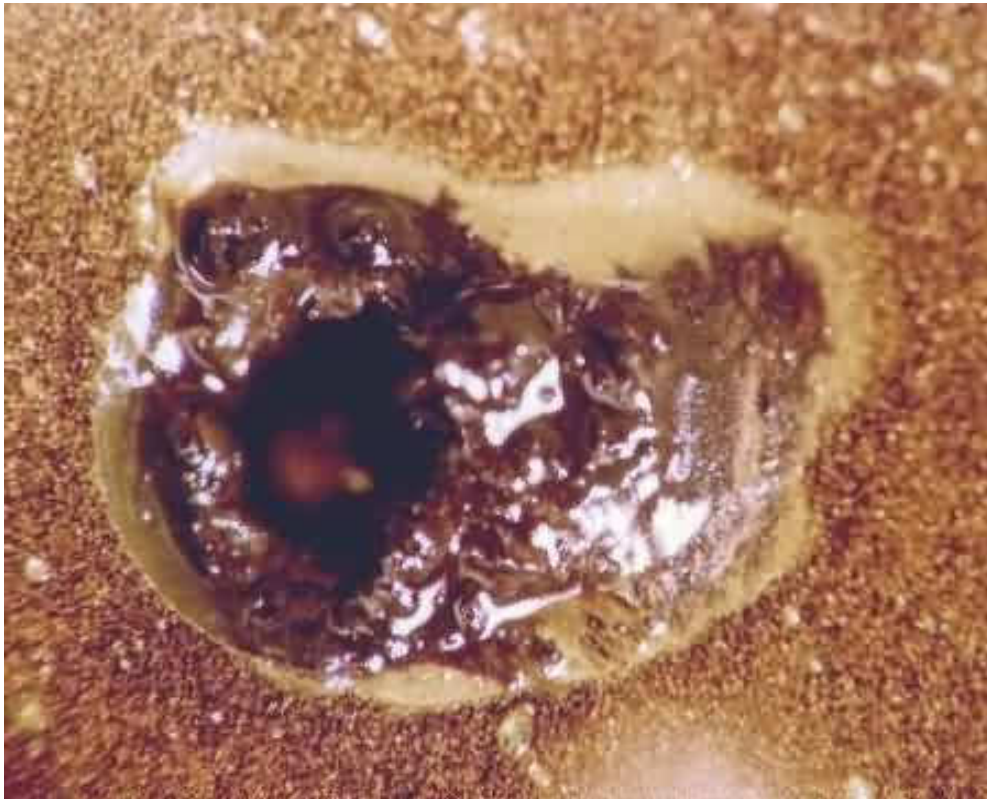
The second bushing has a large amount of black oil paste.

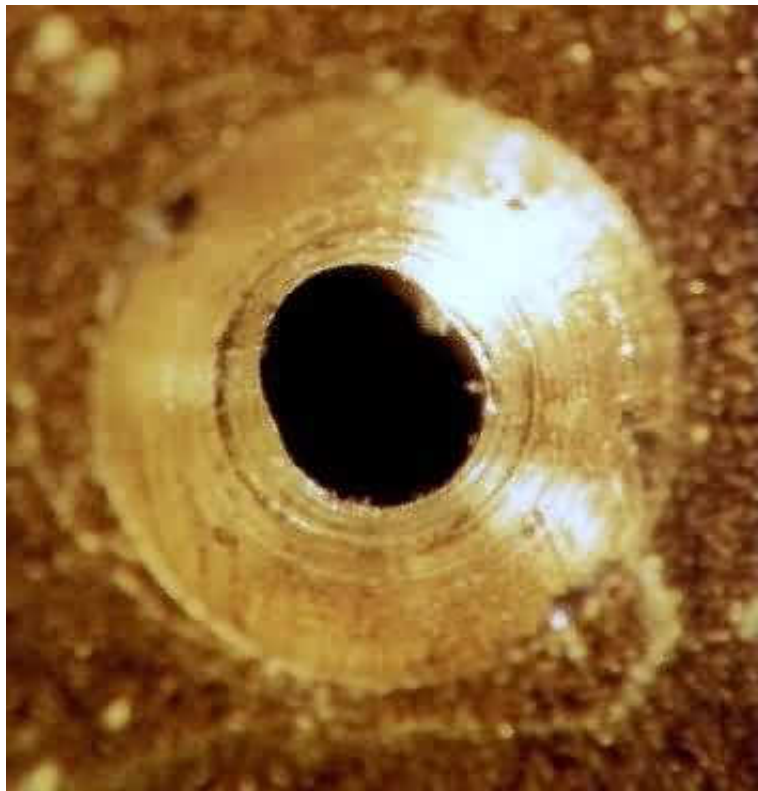
This is the second bushing, after removing the black oil paste, to reveal the obvious wear to one side.

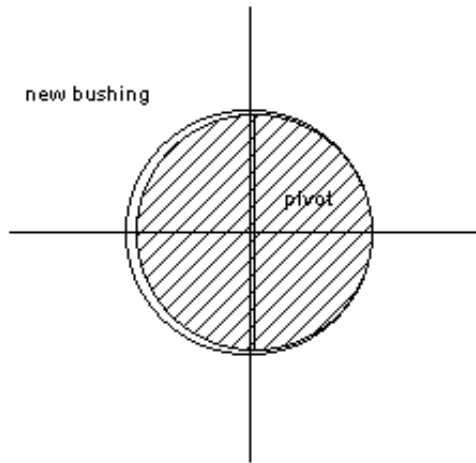
This test requires us to visualize the behavior of the pivot in the bushing. The theoretically perfect pivot is a perfectly parallel cylindrical shaft polished to a mirror finish. The brass bushing is a parallel cylindrical hole with a mirror finish. The bushing hole should be slightly larger in diameter than the diameter of the pivot so that the pivot can rotate freely inside the bushing. Let us imagine, for example, that the preceding gear is located directly below and it rotates in a clockwise direction.

Therefore, the pivot rubs on the right side of the bushing as it rotates. The surface area of the bushing in contact with the rotating pivot is small because the diameter of the hole is larger than the diameter of the pivot. As the bushing wears, the area in contact with the pivot increases dramatically: a maximum of fifty percent of the surface area of the pivot can rub against the bushing.

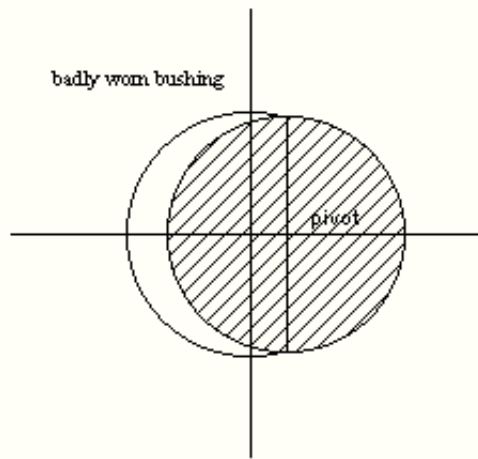
However, it is not the increase in surface area that causes the increase in friction as the surfaces wear, because friction is independent of the area upon which a force is acting. The friction is dependent upon the magnitude of the force acting on the pivot, (pushing it to the right), and the yield pressure of the metals, a measure of the force the metal particle irregularities in a unit area of surface can support before being crushed down. So, all else being equal, the friction taking place in the new bushing is the same as the friction taking place in a worn bushing that has been cleaned, (contrary to most people's expectations), unless the surfaces have become rough. Now think about the foreign particle becoming embedded in the brass that scratches the pivot, as described in the rough bushing test. The rougher pivot scratches the brass. The result is further contamination of the oil in the bushing, which turns from a slick liquid to an abrasive paste of foreign particles, brass and steel powders, with a texture similar to toothpaste. In the new bushing, the hole is larger than the pivot. There is room for the paste to be pushed out of the way. In a badly worn bushing, the hole the pivot has dug for itself is now effectively the same size as the pivot diameter. The paste is thicker than the oil was because of the contaminating particles in it. Since the pivot and the worn portion of the bushing hole are the same size, the paste causes binding. Now consider the same scenario with a dry bushing, or without enough oil to form a paste. If both the pivot and hole surfaces are rough, the roughness could cause a small shift to one side, (much the same way the front tire of a bicycle shifts to one side a little when it rides over a pebble). If this shift pulls the pivot shoulder against the brass plate, a considerable increase in friction or even binding could occur. This would sometimes happen and sometimes not, making its behavior appear to be random. The broach test is also simple, once the logic behind it is understood. Put a cutting broach into the bushing hole to be tested. Turning with a FEATHER-LIGHT TOUCH, determine whether there is any binding of the broach.

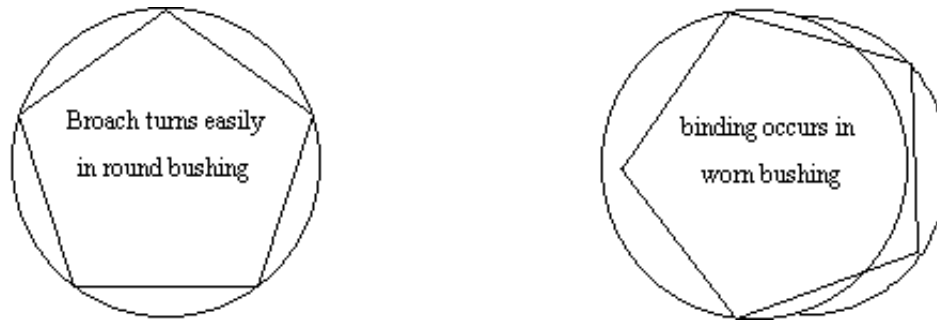
If the hole is anything but perfectly round, the broach will get stuck in the hole and your feather-light grip will slip. I emphasize feather-light touch because if slightly too much force is used, the broach will cut right through the imperfection in the hole and the latter would not be noticed. Also, too much force can result in too much brass being cut, so a bushing would have to be installed. If the broach gets stuck and your fingers slip, the bushing needs to be investigated further. If the broach does not get stuck, then only a minimal amount of brass, maybe 0.02 mm. thick, would be removed. This would expose a fresh, uncontaminated layer of brass, thus serving to recondition the bushing.

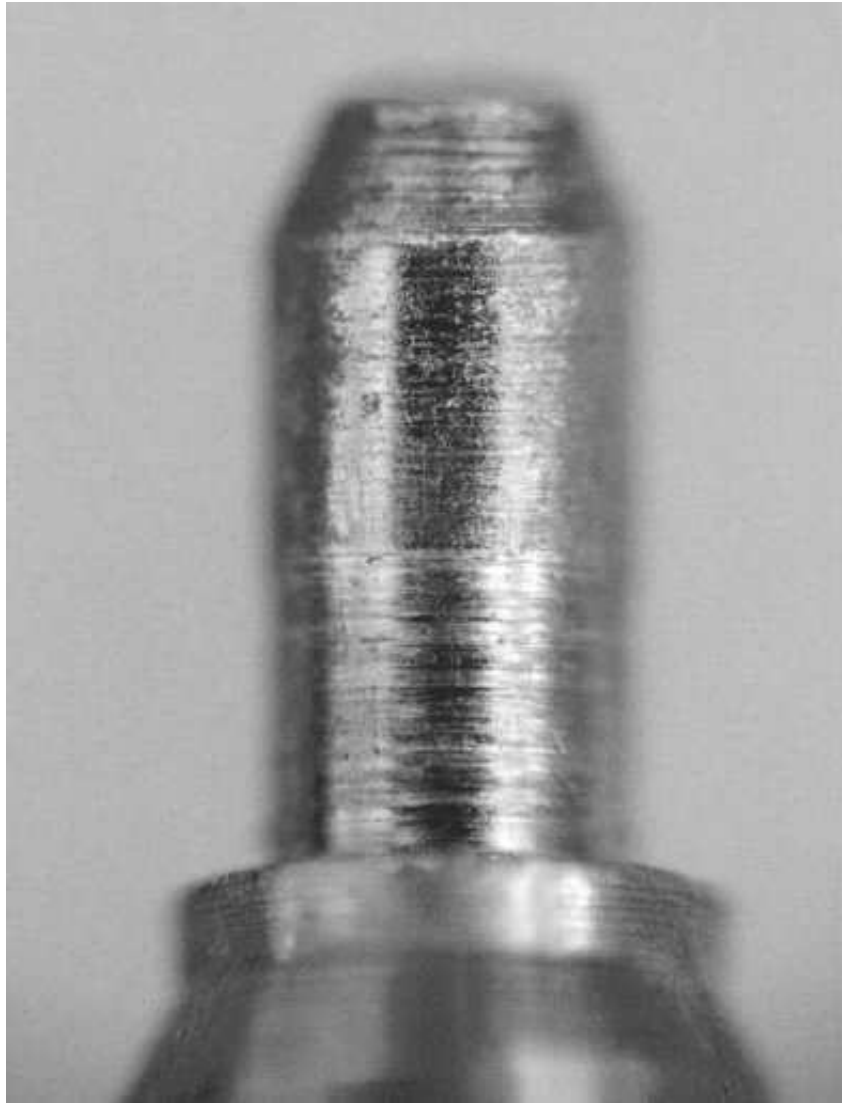
Below is a typically lightly-worn pivot. This photo shows much more detail than you are likely to see with your loupe at the bench, even with a 10x loupe. It would probably look alright and also pass the finger-nail test if the clockmaker were not paying particularly close attention. This photo also shows that the unworn part of the pivot does not have a perfect mirror finish, as is typical of mass-produced clocks.

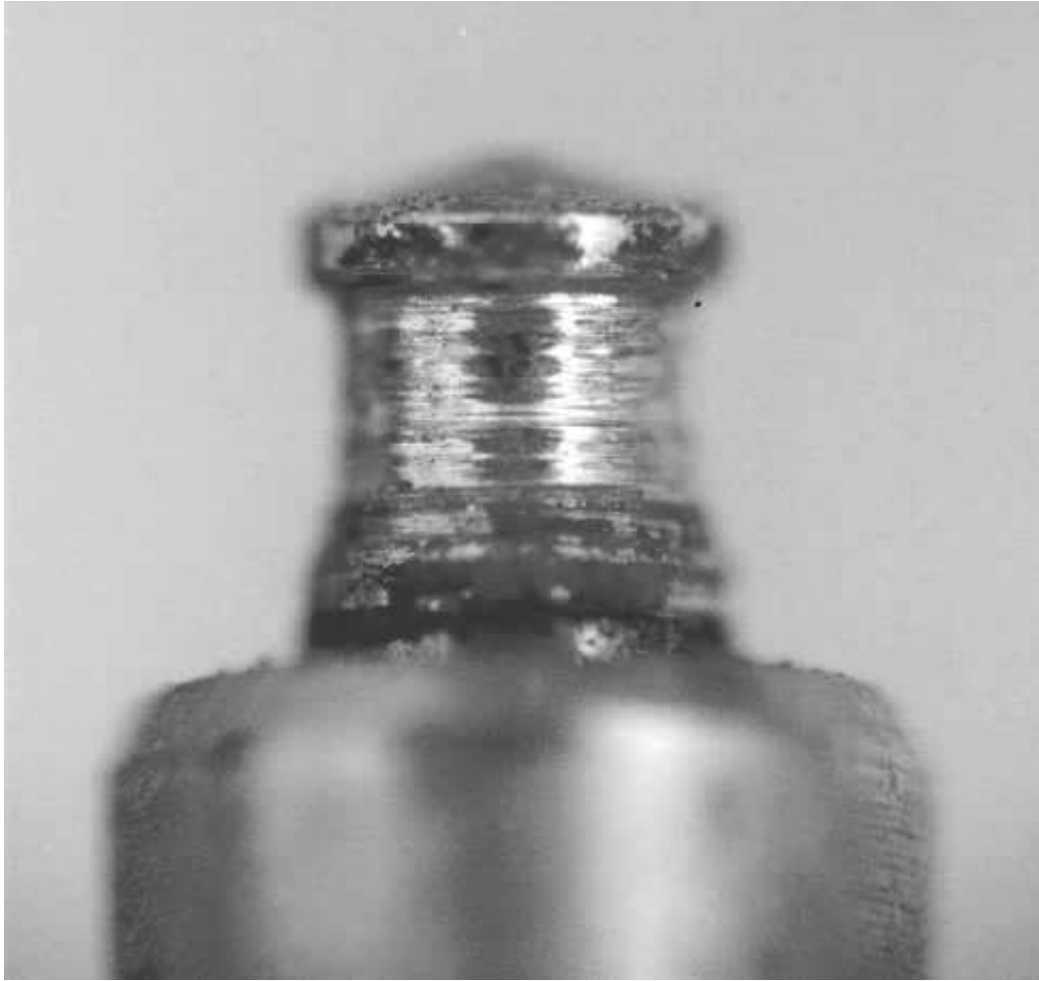
This kind of wear is obvious to the eye, even without a loupe. The cause is rust: once oxidation begins, particles of rust float in the lubricant, acting as an abrasive and causing scoring of the pivot when the rust becomes embedded in the brass bushing surface.

The pivot would have a considerably smaller diameter after polishing, so the bushing would need to be replaced with a bushing that has a smaller hole.

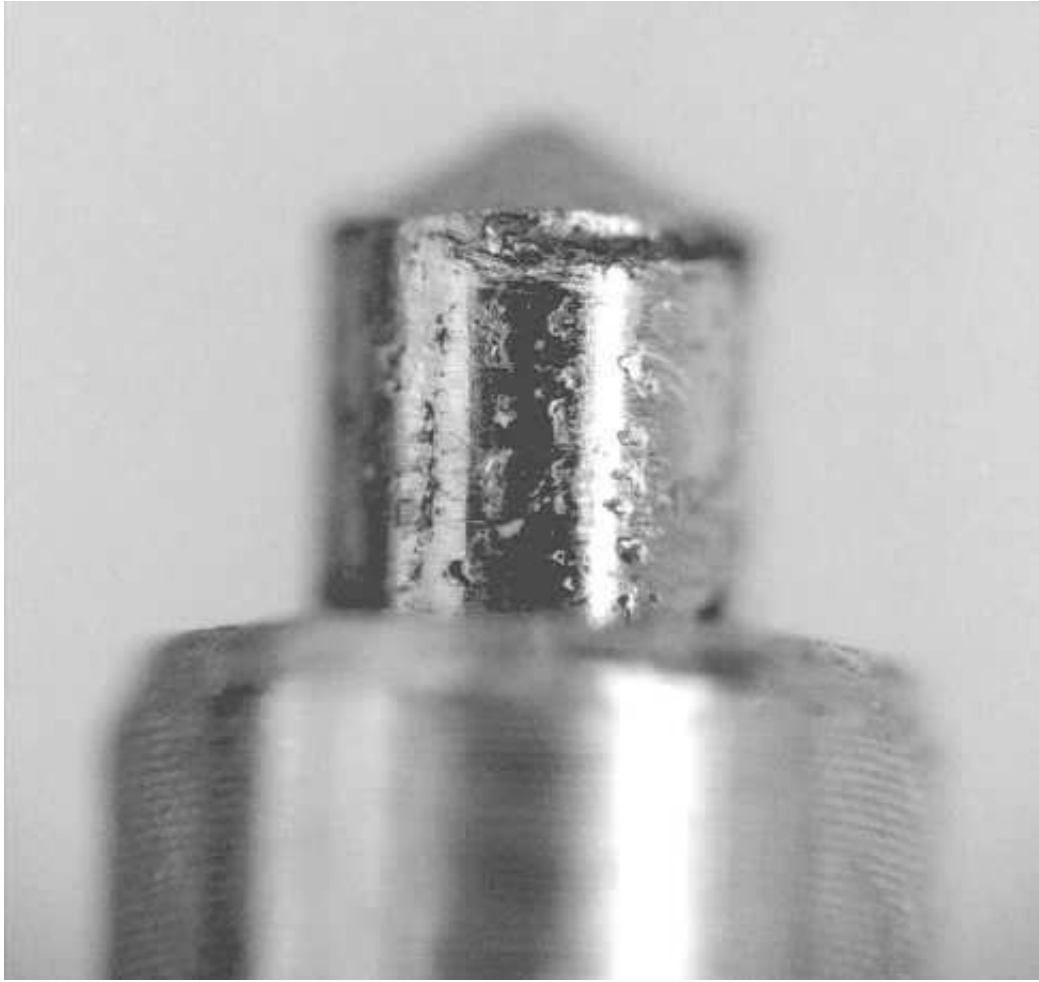
Pivots that are coated with an alloy (for better finish, lower friction and protection from rust) work very well until the lubricant fails.

Once the lubricant fails, if the torque acting on the pivot exceeds the yield pressure of the alloy on the pivot, then the alloy will begin to "flake off" to leave small pits in the surface, which becomes very abrasive and causes the brass bushing to wear at an accelerated rate. This problem with the alloy is common is very common among mass-produced German clocks made since about 1970. The failure of the alloy happens on the second wheel pivots (the gear next to the mainspring barrel), but not on other pivots that have lower levels of torque acting on them. I recommend the thickest grease with graphite and molybdenum disulphide to lubricate these bushings prior to assembly, after repairs are done. This photo shows that the pivot is likely to have once had a near-perfect mirror finish because of the alloy coating.
