Jaeger Le Coultre Atmos 540 Clock.

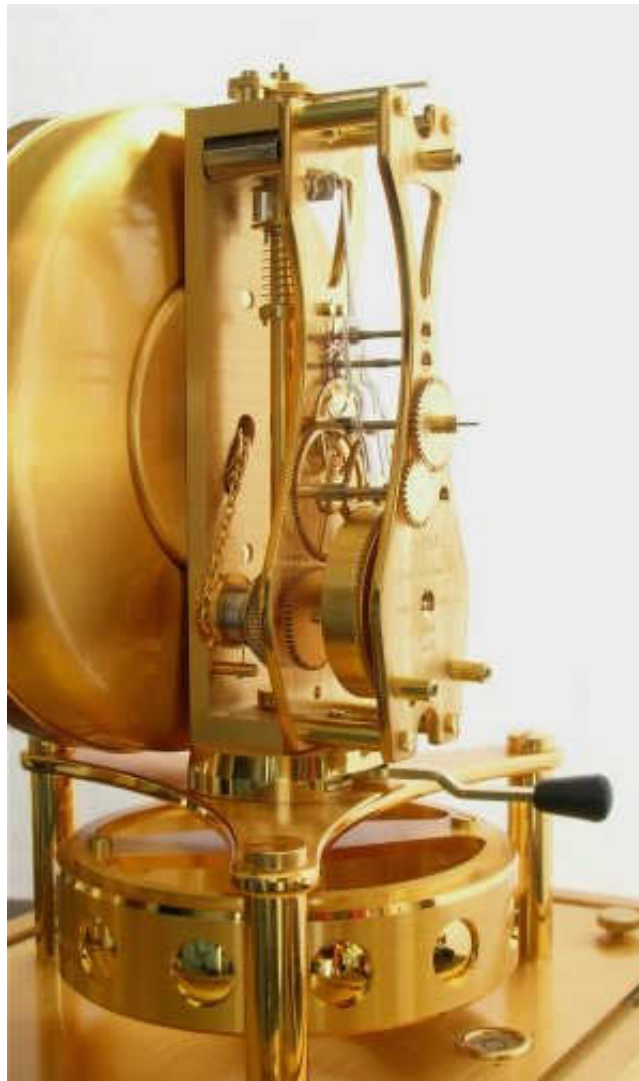
Fig. 1

The Atmos 540 clock incorporates the improvements in manufacturing technology that had become available when this clock was introduced in 1984. It is a truly impressive piece of machinery.

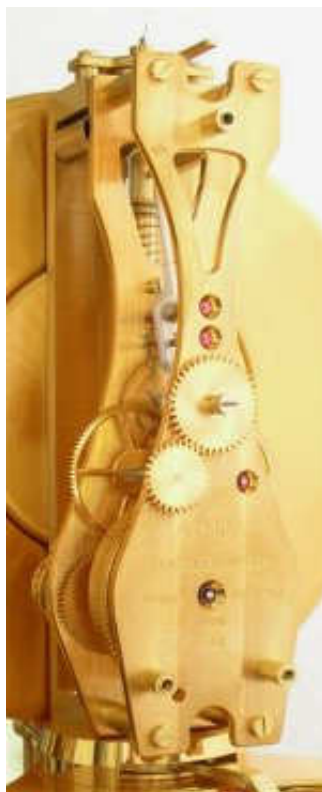
Fig. 2

This clock is less substantial, however, than the Atmos 528. It is certainly more fragile and more easily damaged during repairs because of several new design features that do not amount to improvements. First of all, the bellows must be removed, the chain disconnected from the rear spring, and the smaller chain return spring disconnected from the back plate, all done before removing the mechanism. Otherwise, the tiny click springs will be broken.

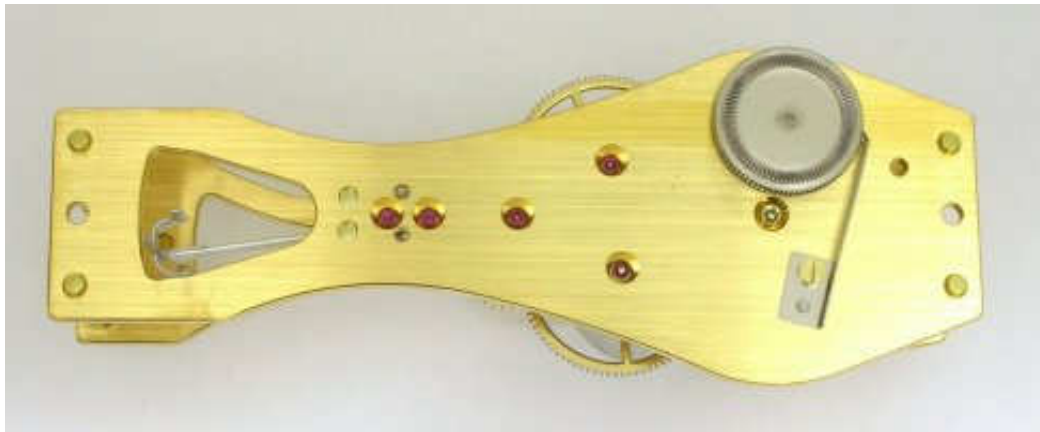
Fig. 3

To let the power down, you hold the ratchet wheel with your fingers while moving the two large click springs out of the way with a pair of tweezers, gradually allowing the ratchet wheel to move slowly between your fingers until the mainspring is fully unwound.

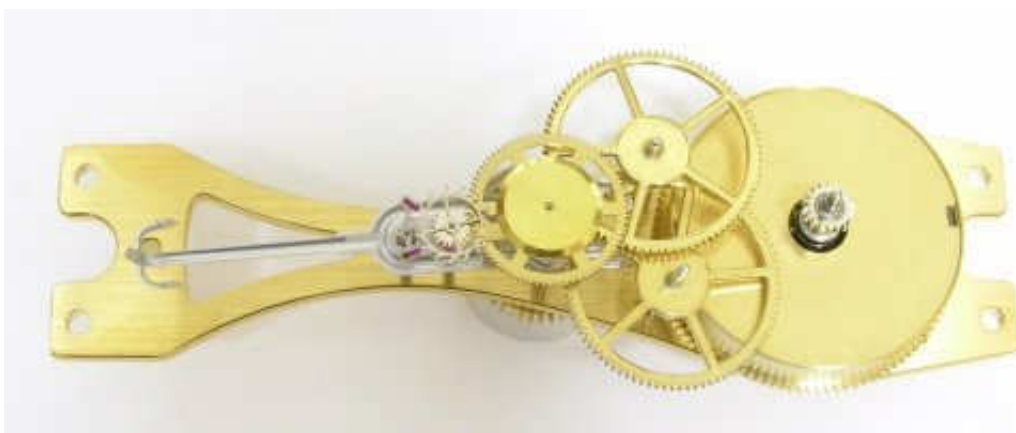
Fig. 4

Make sure the pallet fork protrudes through the opening in the back plate as you assemble the mechanism. Otherwise you will have a broken pallet pivot. The fact that the pallet assembly cannot be added after assembling the mechanism makes this clock far more difficult to assemble than the Atmos 528, with a much greater risk of a broken pallet pivot or escape wheel pivot. It would be an improvement in design to add a bridge for the pallet assembly, as seen in the 528.

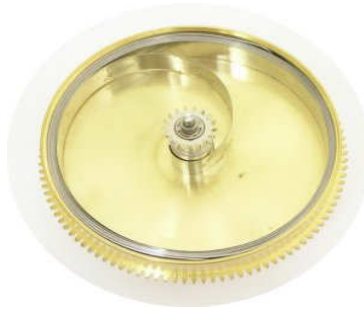
Fig. 5

In the AWI Atmos repair course that I took in 1992, the instructor, Mr. Jerry Jaeger, told us that the mainspring in the Atmos 528 should be removed from its barrel, cleaned, lubricated, and reinstalled. He told us that the mainspring in the Atmos 540, however, should not be removed from the barrel nor serviced unless it were broken and needed to be replaced.
