# Atmos Clock: Replacement of Old Bellows

## Step 1 - Removal of the existing bellows:

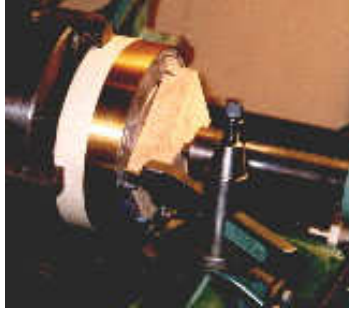
The bellows has been installed in the four-jaw chuck of Dan's large machinists' lathe. The bellows must be centered, of course, and tightened into position enough to enable him to perform the operation but not so tight that the brass housing would be dented: snug, but not really tight. There is a wooden block pressed against the front of the bellows by a live (rotating) center on the tail stock. The wooden block is pressed snugly, but not too tight. The block stabilizes the housing by holding it against the chuck and, as the housing is cut, it prevents the spring force from causing the center of the housing to "pop out" unexpectedly. Here you see the cutting graver in position, set to a diameter just slightly larger than that of the new bellows (by approximately 1/8"):

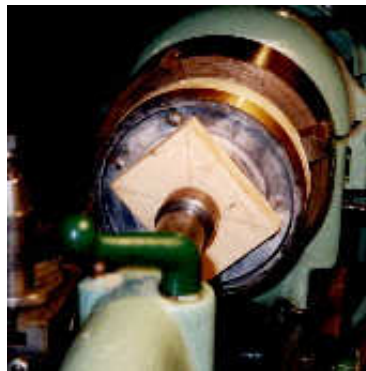
Rotating the bellows at about 150 revolutions per minute, the cutter is plunged very slowly into the housing until the cut is complete. The dangerous part of this procedure occurs when the cutting is almost finished because the graver tends to get caught on the spot where it begins to cut through. Dan adjusted the belt of his lathe loosely so that it was just tight enough to rotate and cut but loose enough to enable the belt to slip when the graver got stuck. Otherwise the bellows could be forced out of the chuck, resulting in dents and scratches. So be very careful. This is a front view after cutting. The cutting on the lathe has been completed.

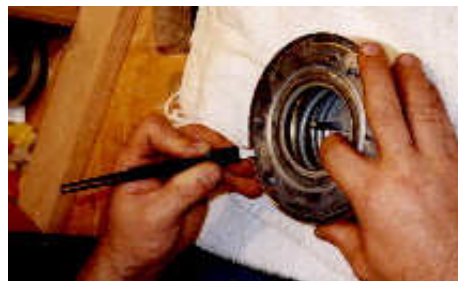
The rest of the cutting is performed by hand with a hobby knife:

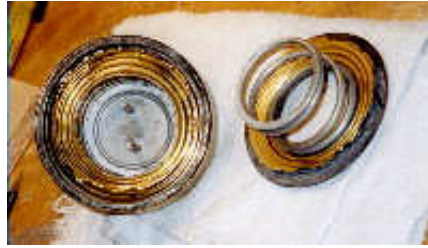
The inner part and the outer part are cut and the top is removed:

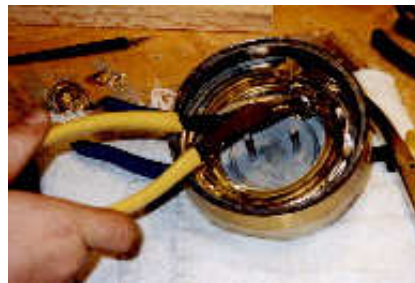
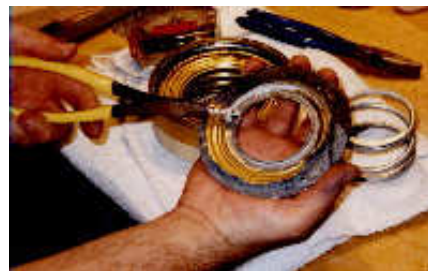
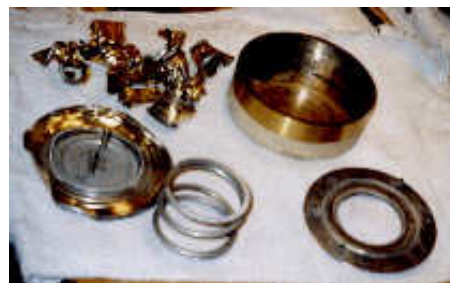
The rest of the bellows is removed with pliers:

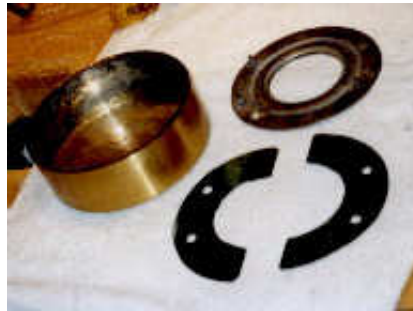
The retaining washers used to re-assemble the housing are fabricated from a piece of tempered sheet metal (0.010" or 0.25mm. shim stock was used). The shape is scribed on the sheet metal. The outside diameter should be just slightly smaller than the inside diameter of the housing. Clearance holes are needed for the mounting studs from the removed plate and also for the center bellows opening (I regret the next photo does not appear sharp, so the markings are not visible):

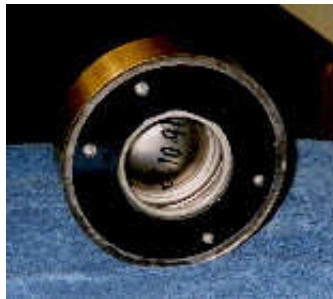
The new bellows is installed immediately (while still cold), the retaining spring placed inside, the front cover (that had been cut out) placed on top, and the two pieces of sheet metal placed on top of the front cover, such that the drilled holes align with the protruding bolts and the outer edges of the sheet metal are wedged inside the outer cover:

Finally, the brass cover is placed into position and the completed bellows replacement is installed onto the back of the Atmos clock as it had been before it was removed. The four nuts are placed snugly to hold the bellows into position, but must not be tightened very tightly because of this repair, so the nuts can be prevented from loosening themselves by applying small quantities of threadlocker (blue Locktite).
