Elliott of London

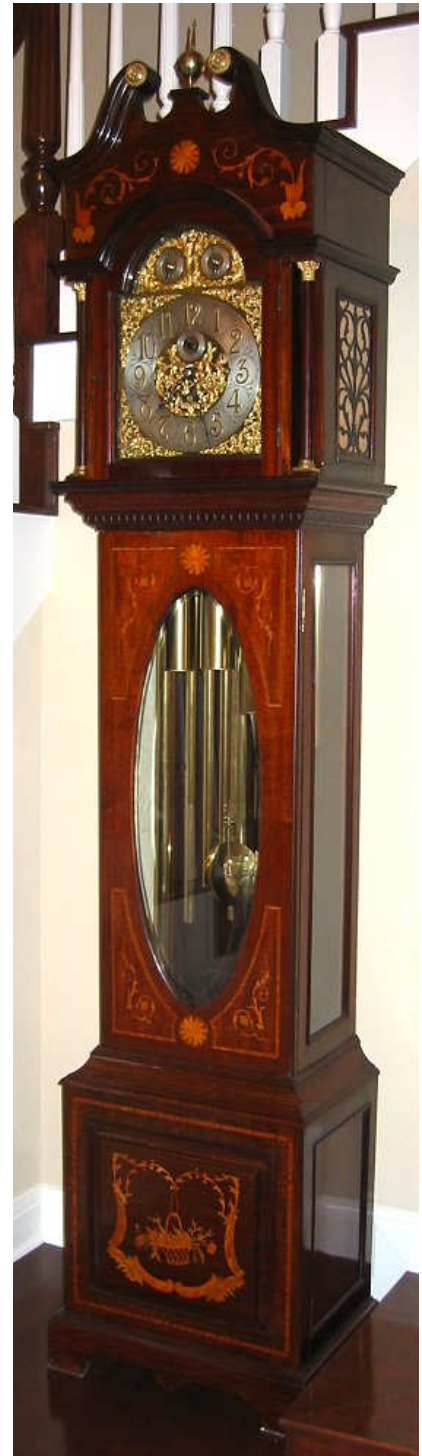
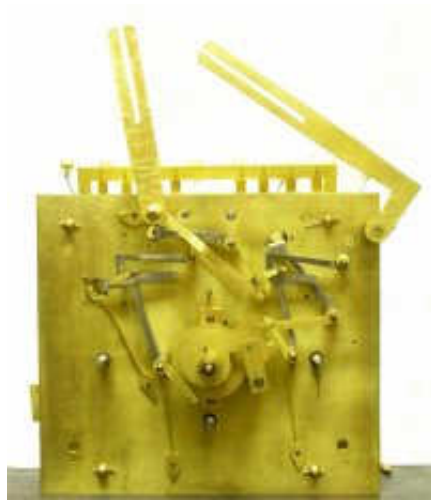
In the dog-eat-dog world of tubular bell grandfather clocks, there were numerous brands. Many high-grade clocks of comparable quality of various nationalities, mainly England, Germany, and the United States, were produced. Among them, Elliott, with the original patent for the tubular bells, was unquestionably top dog. Most manufacturers were trying to develop quality products that were affordable to more people, in order to increase sales, but Elliott went in the opposite direction, making their products deliberately expensive and exclusive for the privileged few. The original owner of this clock could well have paid as much for this clock to decorate his château in about 1910 as he did for his weekend cottage in Surrey. The parts in this clock are large, heavy, well finished, and made of the finest materials. Once the patent for the tubular bells ended, other manufacturers were able to produce their own tubes and compete in the top end of this luxury market. In the United States, Herschede was the main competitor. The Herschede #1 movement is comparable to the Elliott on this page. It was photographed during disassembly.

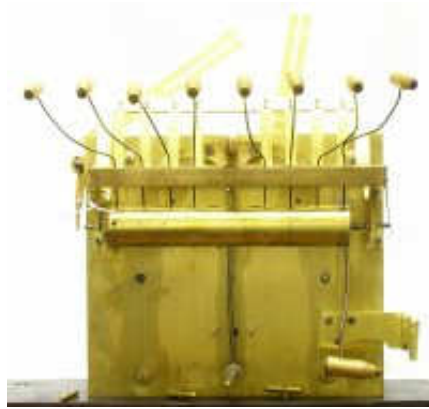
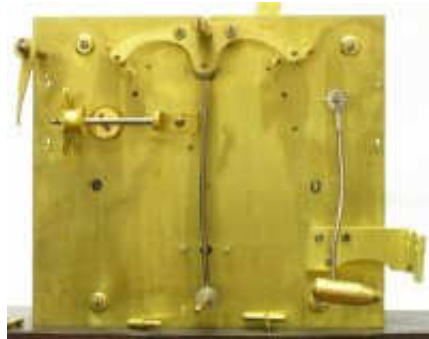
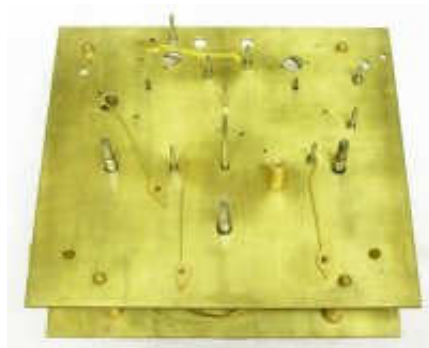
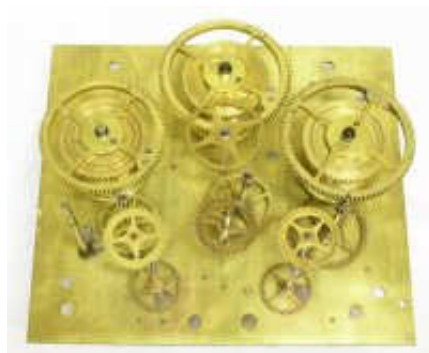
This clock was remarkably clean when it came in for repairs, which is often a red flag. It had chime problems only two years after its last overhaul. Upon disassembly, it was obvious that the person who

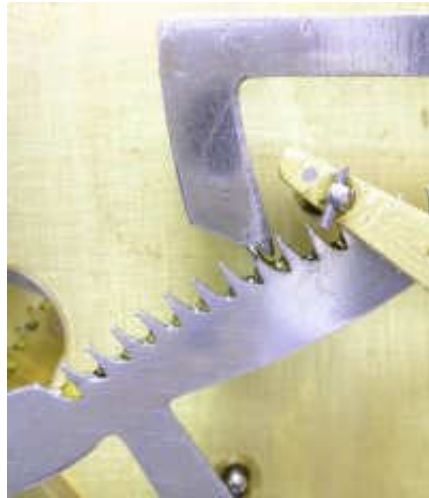
overhauled this clock two years ago had experienced difficulties. The next photo shows the strike rack, loaded with plenty of oil, but it was supposed to be dry. To the left of the rack, you can see a gear behind it, similarly loaded with oil, but also supposed to be dry. Most of the gears were heavily oiled. Only the friction bearings, (the bushings and pivots), should be lubricated. There are other points of friction, such as the escapement, certain cams and levers, that should also be lubricated, but the racks and the gear teeth should be dry. Furthermore, an improper lubricant was used, as evidenced by the presence of rust on the third wheel pivot, shown in the following photo. This clock would not have run for much longer with that rust problem. A proper lubricant will lubricate and protect.

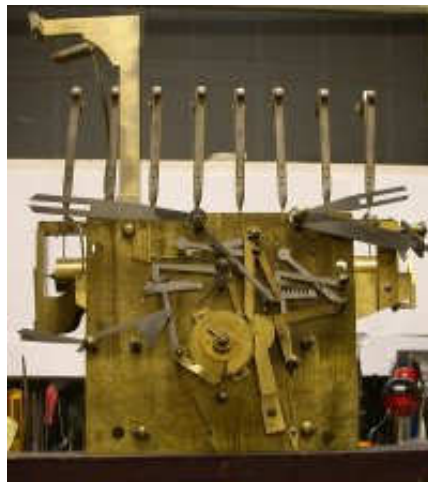
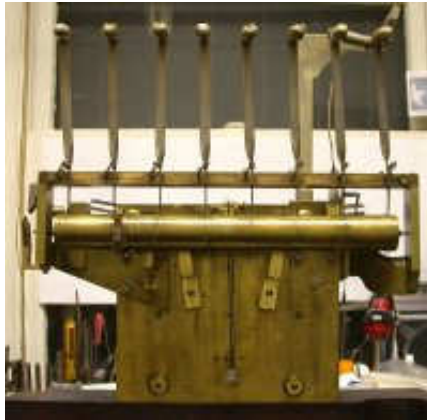
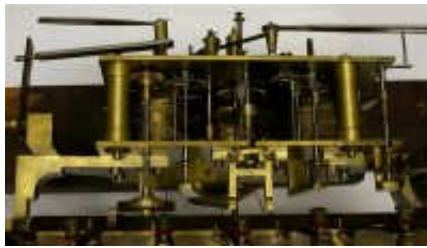
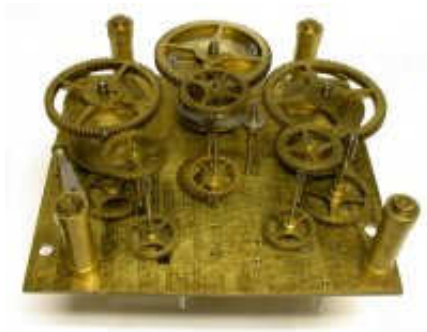
Below are photos of another Elliott clock. The chime hammers are higher in this example because the case was not designed to be compact, quite the opposite. This clock is huge.

This Elliott has a Graham escapement, as it should. However, the parts to adjust the beat of the pendulum are above the escapement, and these parts are relatively heavy, taking power away from the pendulum. Additional weight will be required to overcome this design shortcoming. A comparable Herschede clock, by contrast, has the beat adjustment device mounted onto the pendulum itself, which is much better than having those parts adding weight to the pallet assembly. The pallet assembly should be as lightweight as possible.
