French Carriage Clock

Below are photos of a French carriage clock (circa 1880 - 1890) as it was disassembled. French carriage clocks differed from French pendulum clocks in that they were designed to be portable. They could be moved without affecting the timekeeping. The case made it possible to view the mechanism from all sides, making them especially attractive.

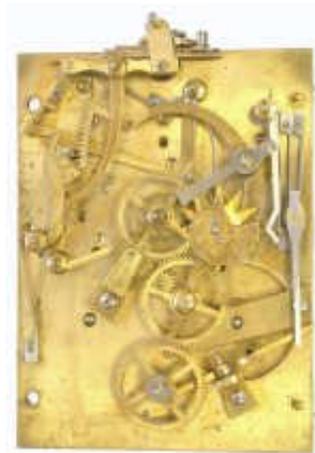
Fig. 1

This carriage clock has a repeater strike mechanism. It has a button on top of the case which can be pressed to hear the strike. This feature made it possible to tell time in the dark. The clock also has an alarum (alarm mechanism). The result is a complicated arrangement of gears and levers. All parts were fitted and finished by hand.

Compare Figure 1 with Figure 11, which shows the front plate of another carriage clock with a non-repeater strike mechanism and no alarm. This layout is similar to many other French clocks. Notice the stopworks on the time barrel.

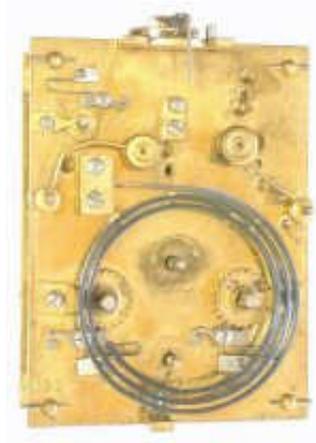
Fig. 2

The rear view in Figure 2 shows the alarm hammer on the left and the hour strike hammer on the right.

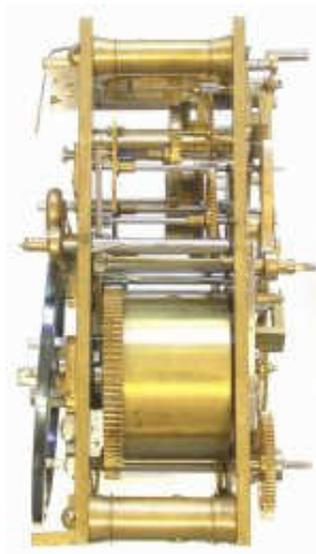
Fig. 3

The side view in Figure 3 shows the gears of the strike mechanism.

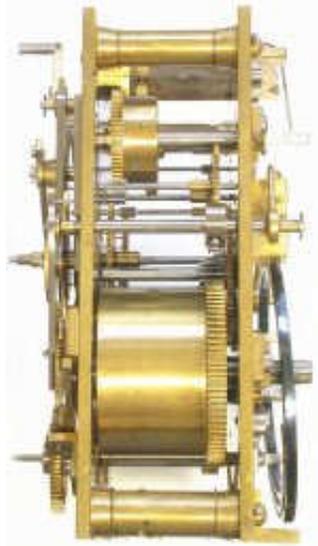
Fig. 4

The side view of Figure 4 shows the alarm mechanism. The mainspring barrel for the alarm is smaller than the others.

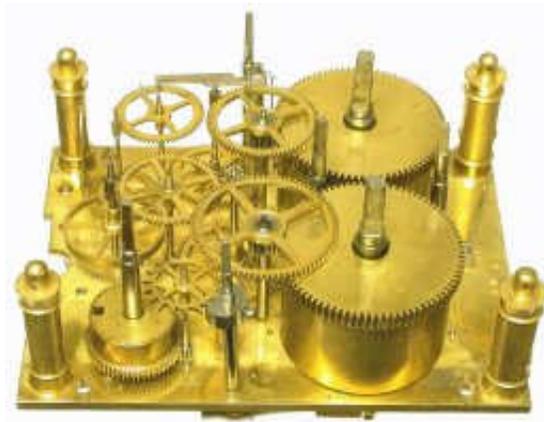
Fig. 5

In Figure 5, the alarm mechanism is in front. The time train is in the middle and the strike train is in the rear. The craftsmanship is superb.

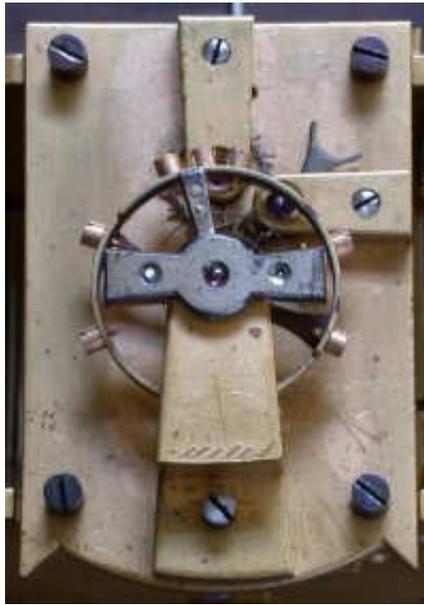
Fig. 9

Anyone interested in escapement theory will enjoy the following photos of an English Lever with a replacement Swiss-type club-tooth escape wheel. It works very well and is actually an improvement because the teeth are much stronger.

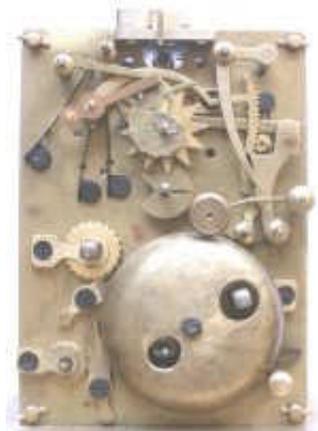
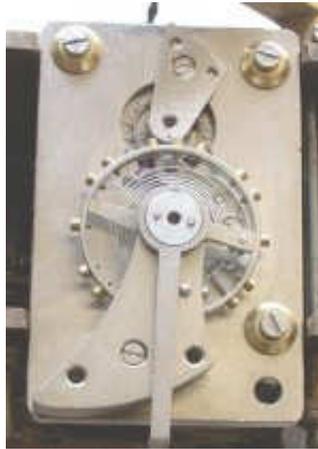
It is difficult to appreciate quality until you have something to compare it to. Figures 12 and 13 show a modern Chinese (?) carriage clock (circa 2001). Despite its numerous features (hour repeater, alarm, day, date), the craftsmanship is no comparison next to a French carriage clock.

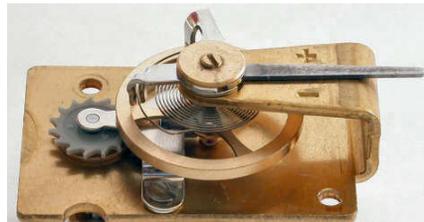
Fig. 14

Here is another interesting platform from a Kieninger mantle clock mechanism (ca. 2002).

Figure 15 shows a platform from a Hermle ship's bell clock mechanism (ca. 2007). Virtually all of the new ship's bells clocks, except for Chelsea clocks, have this mechanism. It appears to have the same plastic escape wheel as the Kieninger platform above, and both platforms have the same problem. When the clocks are in the vertical position, sitting on the table or hanging on the wall, the oscillation of the balance wheel is reduced considerably and the clocks stop at apparently random intervals. However, when the clocks are positioned in the face-up or face-down positions, they work well. My conclusion is that the plastic pallets do not have enough draw designed into them. Lack of draw allows the safety pin on the pallet fork to rub on the roller table, causing the reliability problem.

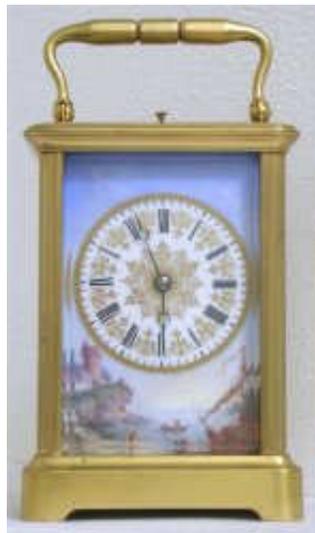
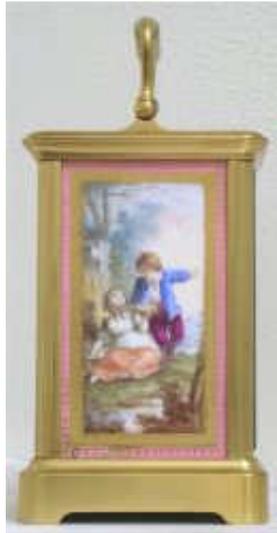
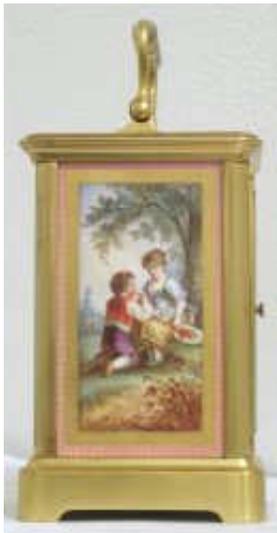
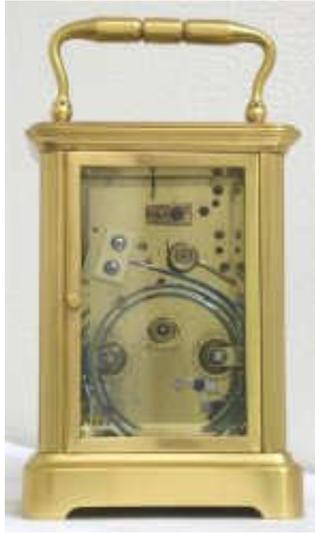
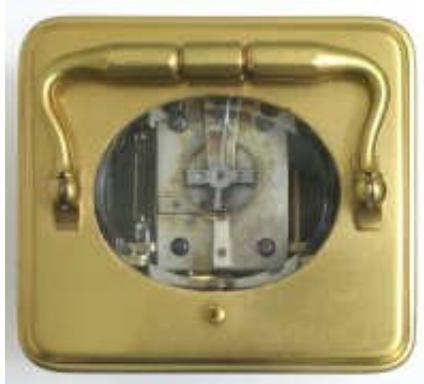
Below are some photos of another French carriage clock, ca. 1890. This one has an hour-strike repeater mechanism. The gold plating is very clean and undamaged. The dial and side panels have enamel paintings. It is stunning.
