# *Herschede*

The first four photos show a Herschede 9-tube grandfather clock mechanism (circa 1980) as it was disassembled. The mechanism is similar in many ways to traditional designs of high-grade tubular bell grandfather clocks. Every effort should be made during repairs to avoid damaging the lacquered finish of these magnificent clocks. Click on the images below to see enlargements (which open in a new window). This is probably the most impressive example of a modern Herschede I have seen. The dial is stunning!

The following photos show a Herschede 5-tube grandfather clock (circa 1956) as it was repaired. This clock was sent from Jamestown, NC. The 5-tube serves as a better example to show the adjustments that need to be made because Figures 9, 12 and 14 would be difficult to photograph with the 9-tube clock above. An entire website could be written about this clock, so this page is only an introduction. All clocks with lacquered plates, including this one, should be cleaned by hand with a mild cleaner. I used a cloth with alcohol. Figure 5 shows what happened to the finish when this clock was once cleaned with an aggressive solvent: much of the lacquer was removed.

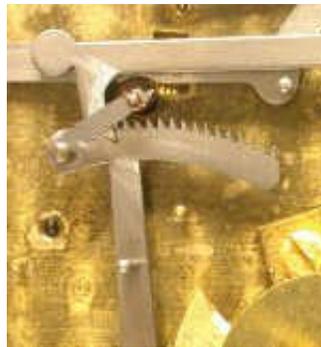
Fig. 10

The procedure has two steps for the strike side. The arrangement of the gathering pallet, the rack and the rack hook is the same as for the chimes. Notice in Figure 10 that someone attempted to repair the rack and the rack hook by filing a deeper locking face on the rack. This should NOT be attempted by anyone who does not understand the proper relationship of these parts (read the strike rack repair essay on this website).

With the gathering pallet tail resting against the rack pin (Figure 10), a pin on the second wheel should have just released the strike hammer lever, so that the strike hammer will have just dropped. This is shown in Figure 11. It will probably be necessary to pry the plates apart slightly to arrange the strike gears in order to achieve this.

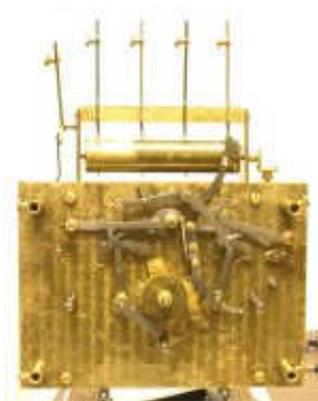
Fig. 13

The assembly of this clock is almost complete as shown in Figure 13. The cables need to be installed. The escapement pallets also need to be installed. With the chime gathering pallet resting against the rack pin, the chime drum needs to be adjusted as follows. There are five hammers (1-2-3-4-5, from right to left, when looking at Figure 13). The drum should be positioned such that the hammers have been lifted in the sequence 1-2-3-4, and the fourth hammer has just been released.

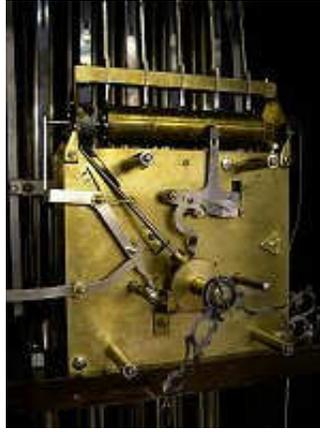
Fig. 15

The last photo in Figure 15 came from the internet. I present it to show you a Herschede five-tubular bell mechanism with two weights (instead of three). If you see a clock for sale with this mechanism, do not buy it. Look for a mechanism with three weights instead. As a general rule, any clock with quarter-hour chimes, like the Westminster chime, and two weights or two mainsprings, should be avoided.
