# Three Schatz Clocks

Schatz Royal Mariner Clock (1975).

This page offers tips for repair of a Schatz Royal Mariner ship's bell clock. The principles are the same for other Schatz ship's clocks and similar for Chelsea ship's bell clocks. The sequence for the bells is the same.

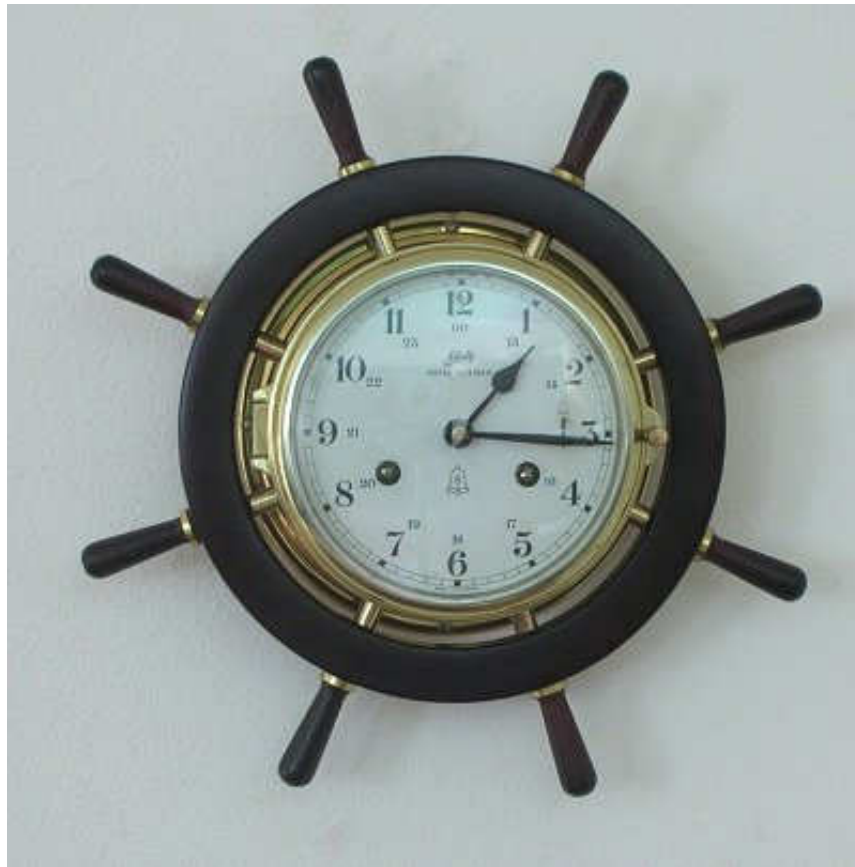
<b>1</b>	<b>12:30</b>	<b>4:30</b>	<b>8:30</b>
<b>2</b>	<b>1:00</b>	<b>5:00</b>	<b>9:00</b>
<b>3</b>	<b>1:30</b>	<b>5:30</b>	<b>9:30</b>
<b>4</b>	<b>2:00</b>	<b>6:00</b>	<b>10:00</b>
<b>5</b>	<b>2:30</b>	<b>6:30</b>	<b>10:30</b>
<b>6</b>	<b>3:00</b>	<b>7:00</b>	<b>11:00</b>
<b>7</b>	<b>3:30</b>	<b>7:30</b>	<b>11:30</b>
<b>8</b>	<b>4:00</b>	<b>8:00</b>	<b>12:00</b>

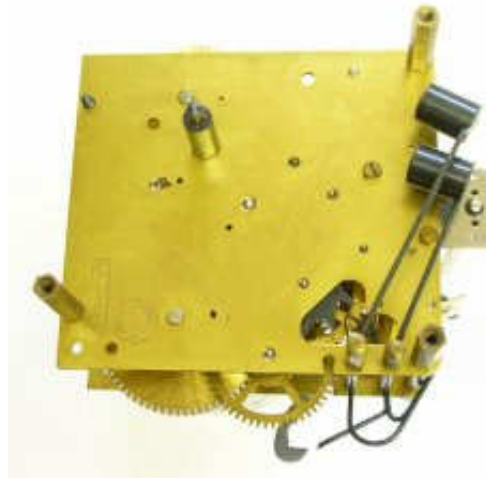
Fig. 2

There is not much to see from the back of the clock.

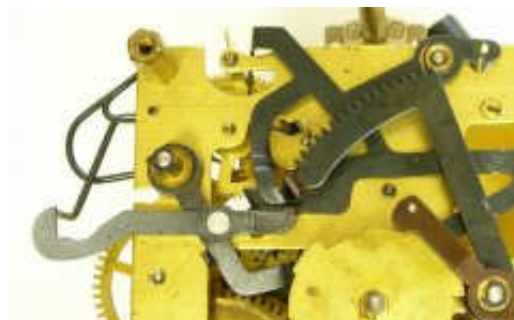
Fig. 3

There is a wealth of information in Figure 3 (click on the images to see the enlargements). At the moment the strike lever falls into the recess of the gathering pallet [A], the hammer detent lever rises just as the hammer is released [B]. It is important for the gathering pallet to be adjusted so that striking stops as soon as the last hammer is released, or this feature will not work. The strike gear train is stopped when the strike lever falls to impede the rotation of the warning wheel [C]. There is a cam on the centershaft that determines the position of the hammer detent lever. When the cam raises the lever, this is the half-hour position. Each step on the snail has two positions (the half-hour and the hour). If you compare the half-hour position in Figure 3 and the hour position in Figure 4, this will become clear. I have seen several ship's clocks that were not correctly adjusted because the repairer did not understand it.

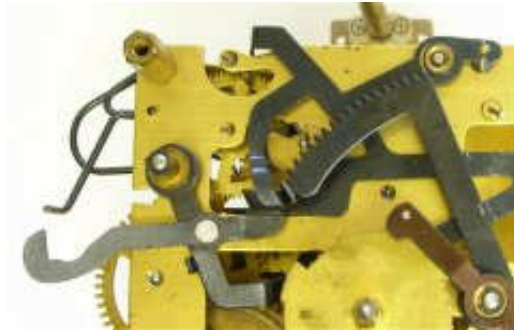
Fig. 4

In Figure 4, the hammer detent lever misses because the cam on the centershaft does not raise the

lever. This is the hour position.

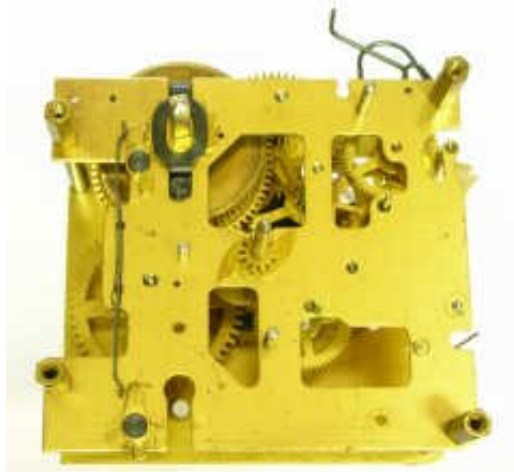
Fig. 5

Most of the parts have been removed from the front plate in Figure 5. It shows how the mainspring barrels are installed and how easily the barrels can be removed without taking the entire clock apart.

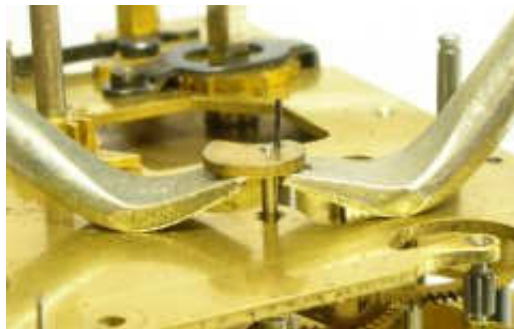
Fig. 6

Figure 6 shows the tools used to remove the gathering pallet. It is important that the gathering pallet be pulled upwards and not to one side (or the shaft will bend or break).

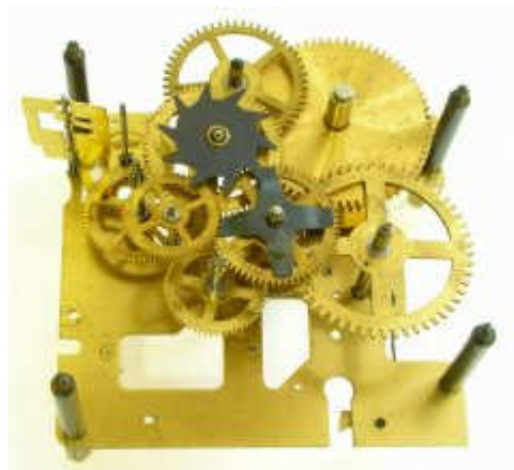
Fig. 7

The arrangement of the gears is shown in Figure 7, after the back plate has been removed.

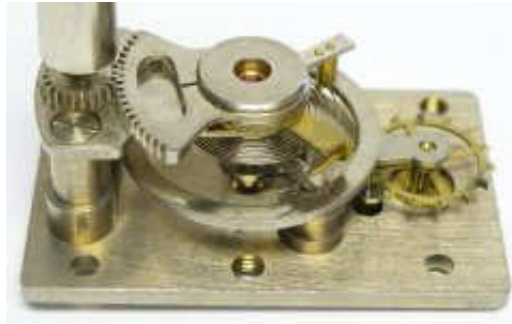
Fig. 8

Figure 8 shows the platform escapement of the Schatz Royal Mariner. It has a pin pallet escapement. The most important problem that happens with this platform is that the bushings for the escape wheel wear and need to be rebushed. An improvement would be to install friction jewels to replace the bushings, though the effort may not be justified in an escapement of this quality.

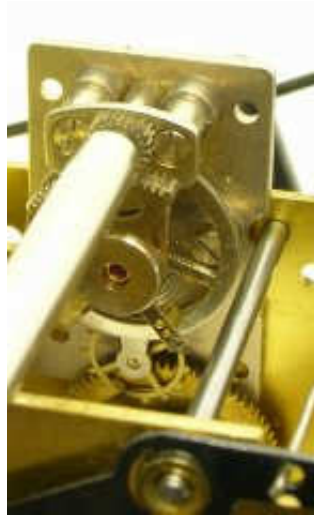
Fig. 9

When you compare the Schatz Royal Mariner with a Chelsea ship's bell clock of similar vintage, there are several obvious differences. The Chelsea is better made, with polished pinions and gold-plated brass gears. The Chelsea platform has a Swiss lever escapement with 11 jewels. The Chelsea costs many times more! Chelsea clocks in general are more difficult to work on than Schatz and other equivalent clocks, so repairs on Chelseas should not be attempted by those without at least five years of experience at the bench and some watch repair experience. Schatz clocks are no longer being manufactured, but Chelsea clocks are. Another manufacturer of ship's bells clocks that should be mentioned here is Hermle.

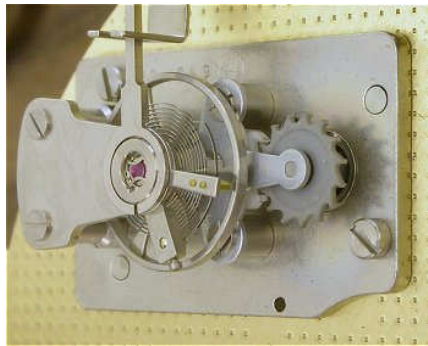
The new Hermle ship's bell clocks have platforms with plastic escape wheel and pallets. The plastic parts should never be lubricated because the lubricants may react with the plastic! The second wheel bushing on the front plate of the Hermle is very close to the edge of the plate, making the replacement of the bushing difficult. If you buy a new mechanical ship's bell clock that is not a Chelsea, it probably has a Hermle mechanism.
