Seth Thomas 89

Sessions Clock

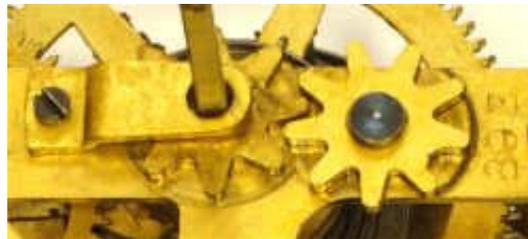
Some of these clocks have stopworks to prevent you from winding the mainsprings too tightly, a terrific feature that every clock should have.

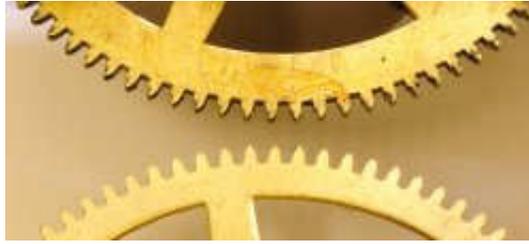
If you wind the mainsprings too tightly, or if stronger mainsprings are installed than were originally there, the result could be damage to the gear teeth. Whereas European clocks have mainspring barrels with long teeth for added strength, American clocks with open springs, (no barrel), have short teeth. The result is that all the torque of the mainspring is applied to a very small area of tooth such that, when the mainspring is fully wound, the teeth become compressed as the yield pressure of the metal is exceeded. The other gear in the photo below shows undamaged teeth. The compressed teeth look worn, but you do not see comparable wear on the lantern pinion of the second wheel, so you conclude that compression took place. Close inspection reveals that brass was pushed to the side, and the edges of the teeth are no longer smooth. Thinner mainsprings should be installed on this clock. I recommend 0.0165 inches thick.

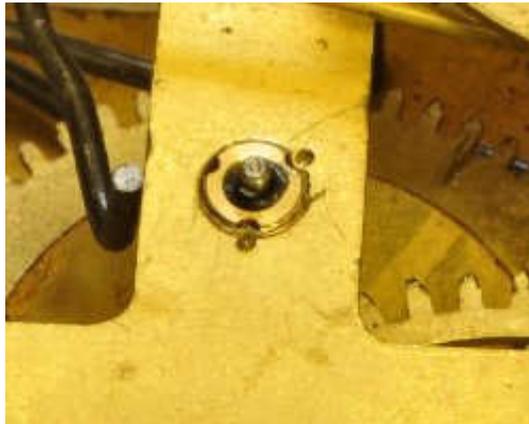
Below is an example of a screw-in bushing. Some repairmen use them because they can be installed without taking the clock apart. However, if the clock is not taken apart, you cannot polish the pivots. A rough pivot is probably what caused the bushing to wear in the first place. Furthermore, screw-in bushings are ugly and tend to unscrew themselves if not carefully punched in place. This type of bushing is not recommended. If you encounter one at the bench and you find that it has no visible wear and does not tend to unscrew itself, then you may decide to leave it alone in a production-grade clock. Otherwise, replace it with a friction bushing, such as a Bergeon bushing, but a friction bushing of this size will probably have to be custom-made on a lathe. If the clock you are working on is high grade, including Chelsea clocks, Herschede clocks, Elliott clocks, and French clocks, you should consider installing a friction bushing.

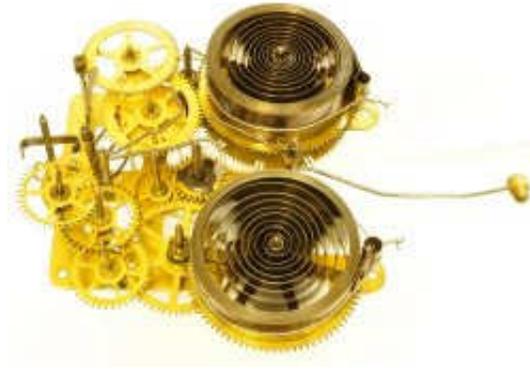
This clock came in for repair because it would not strike. The lift lever is badly bent out of shape. This kind of damage does not happen by itself, but rather because of improper repairs. The escapement, clearly visible in the next photo, is called a Semi-Deadbeat because the exit pallet acts as a deadbeat but the entry pallet acts as a recoil. If you find one of these clocks with a longer pendulum, such as you would find in a larger wall clock, you would be surprised by how well it keeps time, compared to other production-grade clocks.

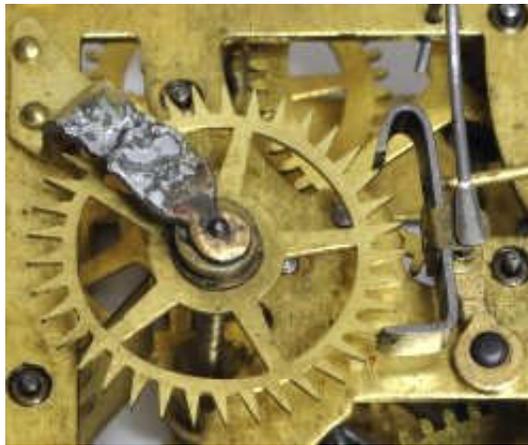
In order to avoid taking the clock apart, someone soldered a Rathburn bushing over a worn bushing. Apart from looking awful, this may have worked if the pivot had been polished. However, to polish the pivot, the entire clock must be disassembled, so you might as well install a friction bushing. Shortcuts are not worthwhile when it comes to bushings and pivots. Any time you see a Rathburn bushing, you should remove it when servicing the clock. The rough pivot was the reason why this clock would not run. In fact, all the pivots in this clock needed to be polished, some more rough than others. This is one of the problems with mass production: lack of attention to detail usually results in imperfectly-polished pivots.

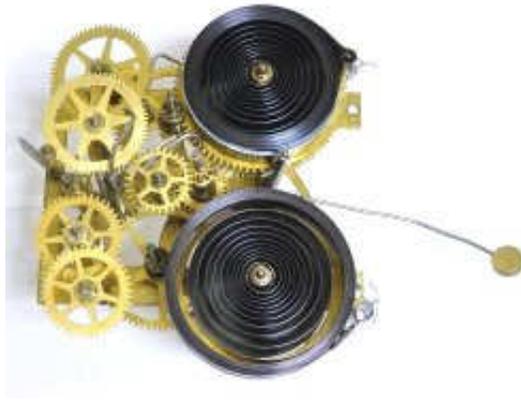
The escapement is a Strip-Pallet Recoil Escapement because the pallets are made from a strip of steel, (just like the Seth Thomas 89 above). This clock is a nice piece of American history and every collector should have one.
