Herschede - Revere Clocks

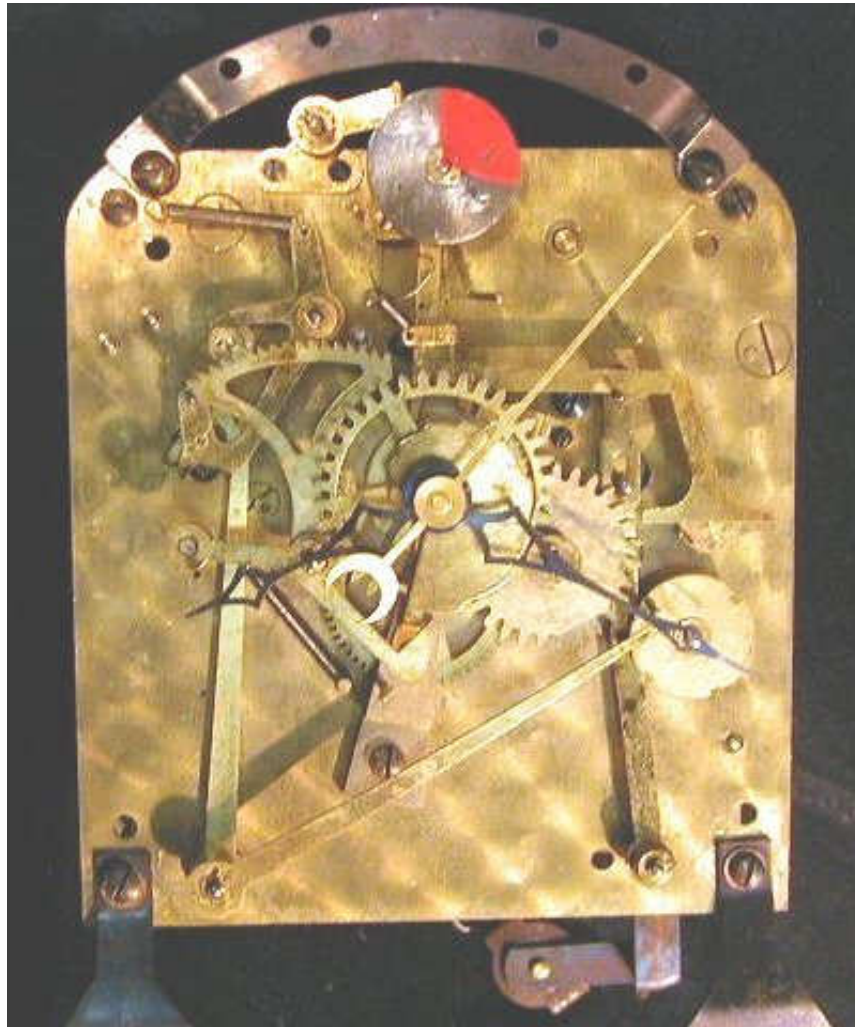
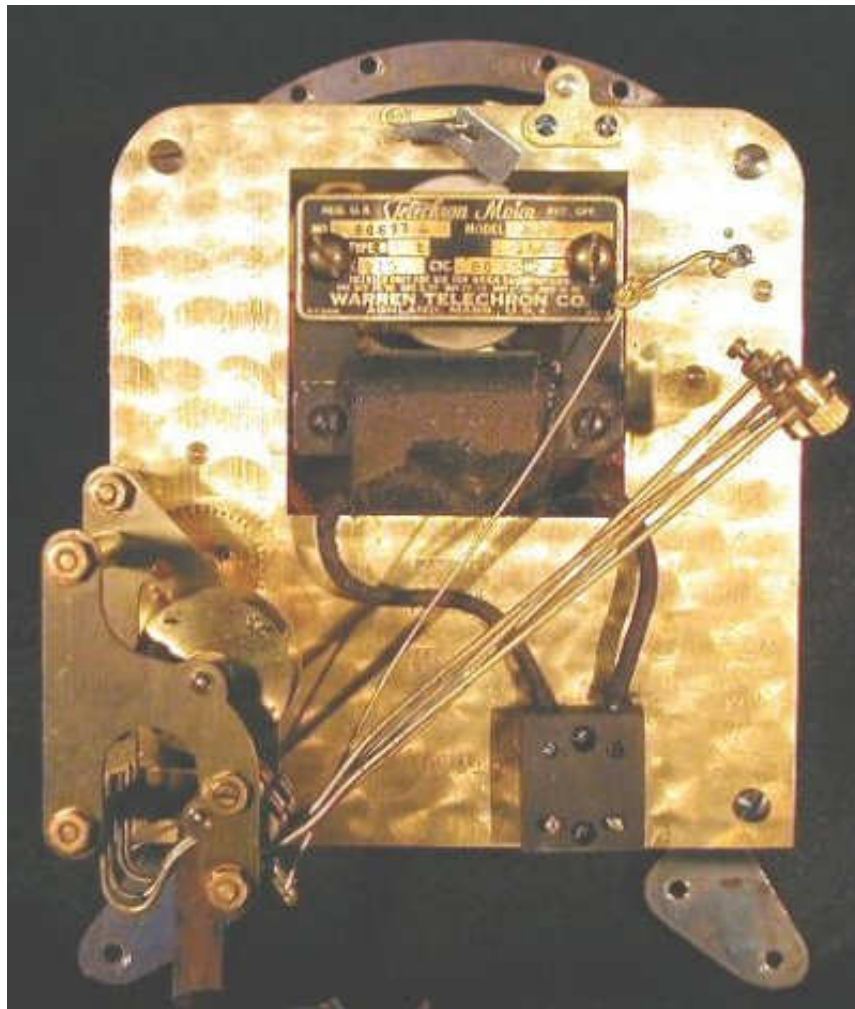
Walter Herschede and Henry Warren worked together in 1925 to produce an electric clock with chimes, resulting in a new line of clocks, called Revere Telechron, in 1926. These clocks were manufactured by Herschede, which can be seen in the photos below. Figures 1 and 2 show a Revere Model 100 (1929) large, two-plate movement:

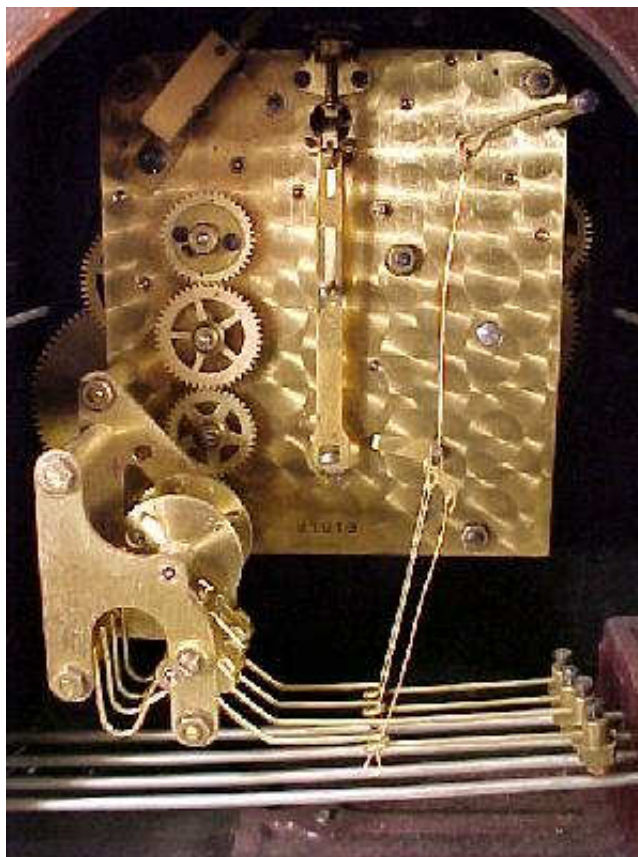
Fig. 3

Figure 3 shows a mechanical Herschede with Westminster chimes from the early 1920's.

The Revere clock was obviously based on this clock. Several Revere models were produced, including Model 120 with five tubular bells for grandfather clocks. These clocks were large, heavy, and obviously expensive. Below is one more example, a Herschede with a Telechron motor and a pendulum. This clock has Westminster and Canterbury chimes. It cost \$91 in 1929. When you consider that a Model T Ford cost \$256 in 1925, this mantel clock was probably cost-no-object engineering! Click on Figure 4 to view an enlargement, which will open in a new window.

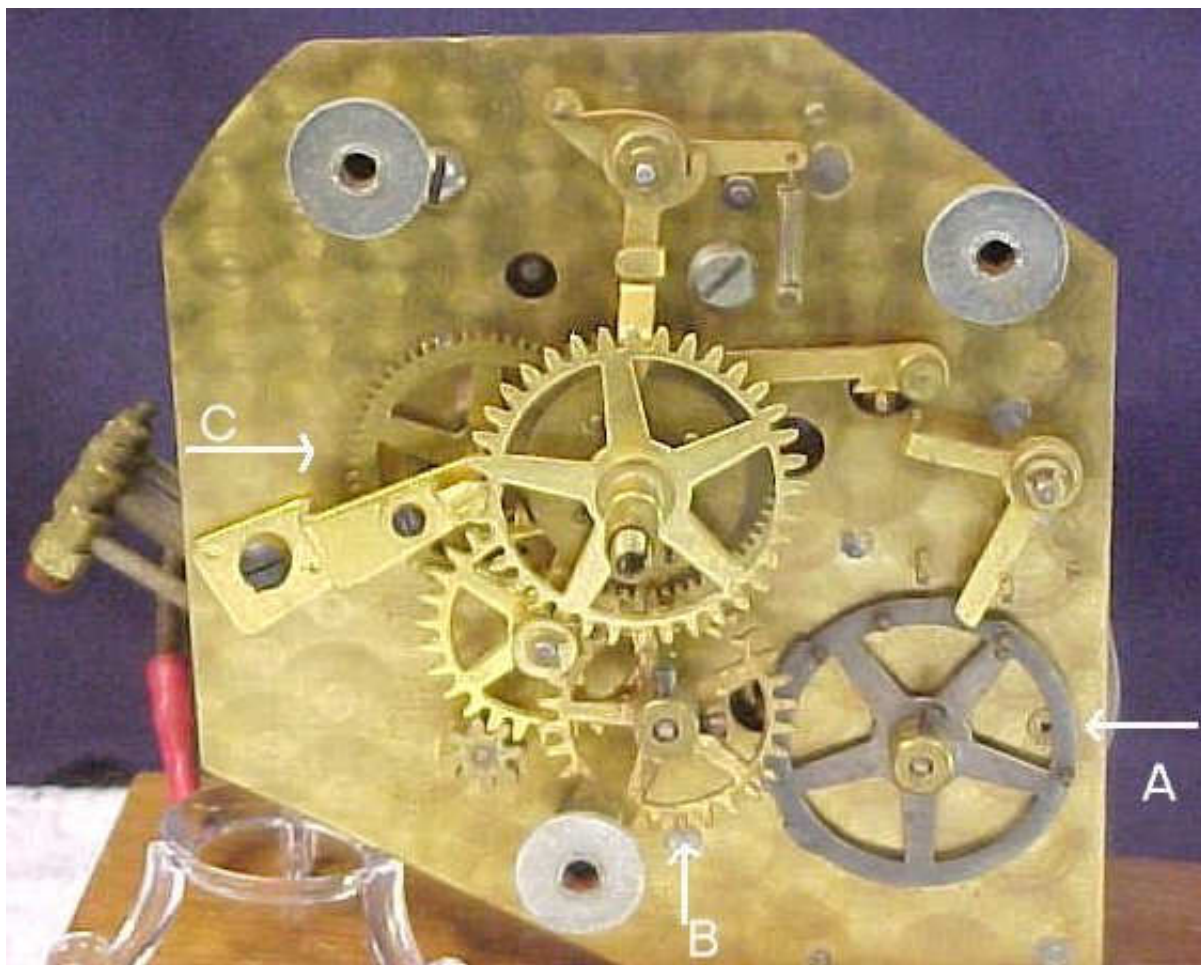
Fig. 5

Shortly after the introduction of Revere clocks, a new Model 100 single plate movement was introduced, probably around 1932, with the chimes and strike cleverly combined to reduce the number of parts needed, simplifying the design and reducing production costs considerably. The photos below show this movement. Most Revere clocks produced between 1932 and 1959 have this mechanism. Despite the reduction in size and cost, it works just as well as the more expensive models!

Adjusting the chimes, when assembling this clock, involves one simple step. As shown in Figure 9, put a wire through a small hole in the locking disc, through the hole in the movement plate, and through the hole in the chime cylinder drive gear (see also Figures 5, A and 7, A). Then tighten the screw on the locking disc.

Adjusting the strike involves two steps. Put the minute hand onto its post on the center shaft and move it to the hour ("60"). As shown in Figure 9 below, put a wire through a small hole in the back plate (or cylinder bridge) and through the hole in the hour control wheel. Then tighten the two screws on the hour setting wheel (also see Figures 5, B; 6, D; and 7, D).

There is a copper spring under the minute wheel (see Figure 5, C) which can be removed because it creates a lot of friction and wear. It is intended to keep the hands from moving slightly while the clock chimes. This slight movement does not bother me, so I have removed the copper springs from my Revere clocks.

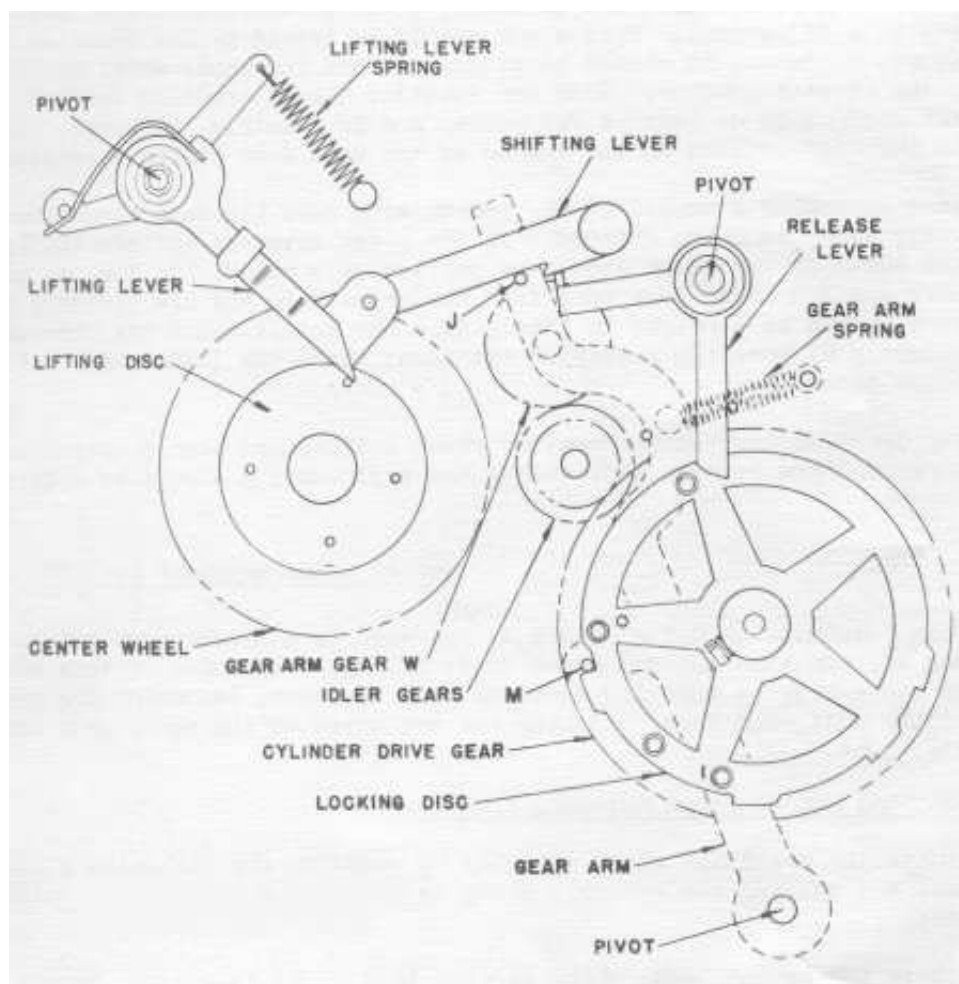
Fig. 8

The chimes are activated when the lifting disc (see Figure 8), mounted on the center shaft, moves the lifting lever until the shifting lever engages the pin (J) on the gear arm. At the moment the lifting disc releases the lifting lever, the shifting lever pulls the gear arm to the left, so that the chime gear on the gear arm engages the center wheel. The clock chimes until the chime cam (or locking disc: see also Figure 5, A) lifts the release lever up, causing it to unlock the pin (J) from the shifting lever. The other pin (M) on the gear arm presses against the locking disc until the disc allows it to fall into a slot. If none of the chime hammers are being lifted at the moment the pin (M) is to fall into a slot in the locking disc, the gear arm moves to the right and disengages the chime gear from the center wheel and the chiming stops.
