A Tribute to a Korean Clock

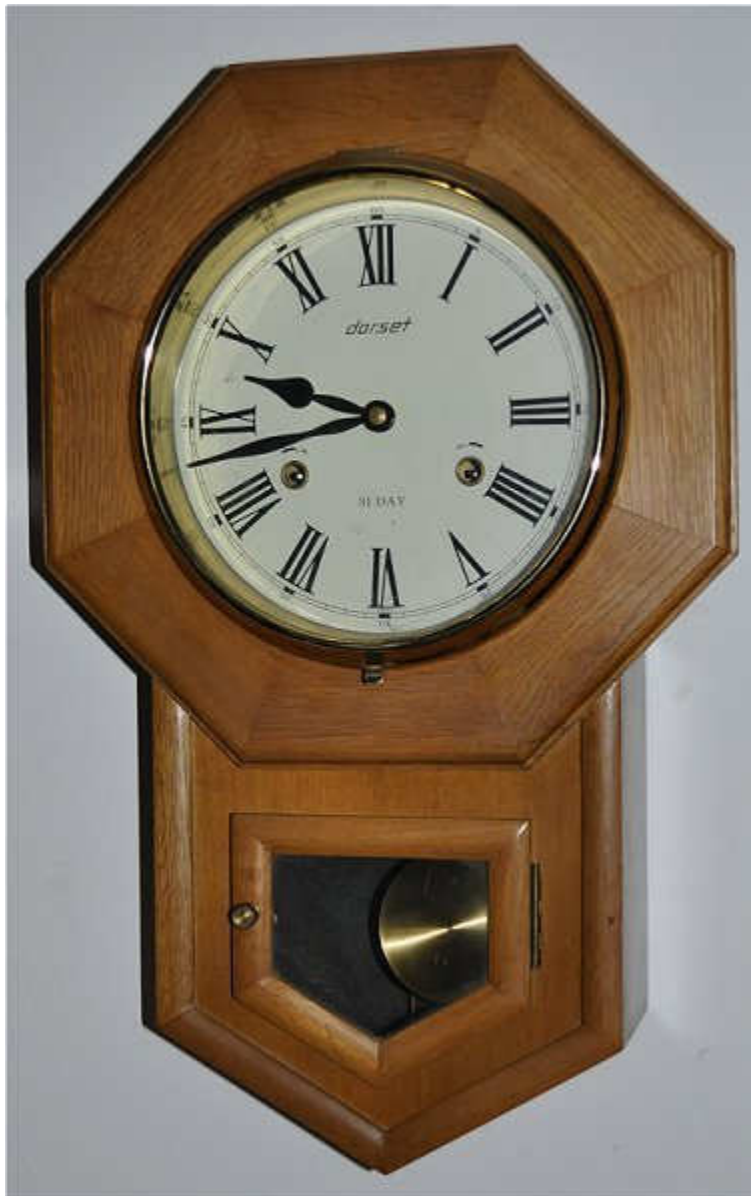
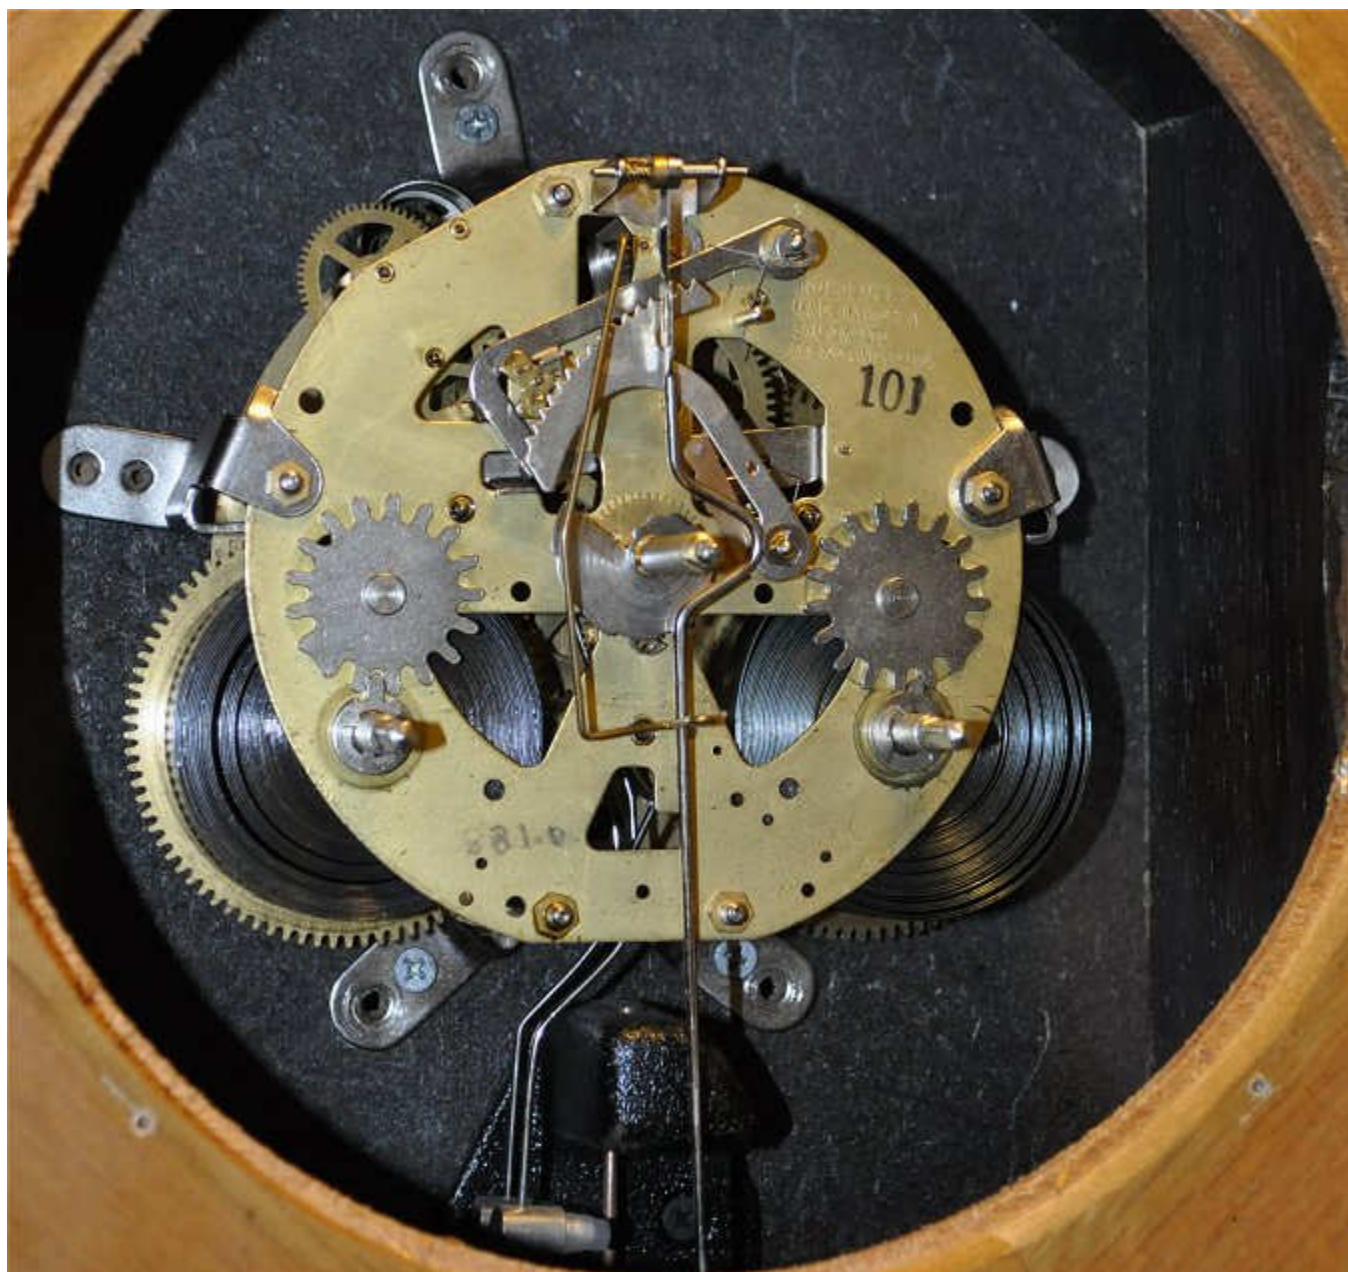
This particular clock does not say "Montgomery Ward" on the dial, but it has the same mechanism. It has a semi-deadbeat escapement because the locking faces of the pallets are not curved, so a small amount of recoil does take place. The clock also has mainsprings that are 3/4" wide, similar to American clocks, so I wanted to compare my Korean clock to my Seth Thomas 89, which also has a semi-deadbeat escapement. Let me quote from a previous essay: "It is worth mentioning that the Timesavers catalog has a 3/4 x 0.015 x 170 inch mainspring for Japanese and Korean 31 day clocks from the 1970s and 80s, because some of their mechanisms look like copies of American clocks from the early 1900s. A 0.015" mainspring, when installed in a Seth Thomas 89, should have a calculated length of 169", and it would have 58% of the strength of a 0.018" mainspring. They were obviously onto something there." I believe that clocks from the Orient were different when compared to American and European clocks because the

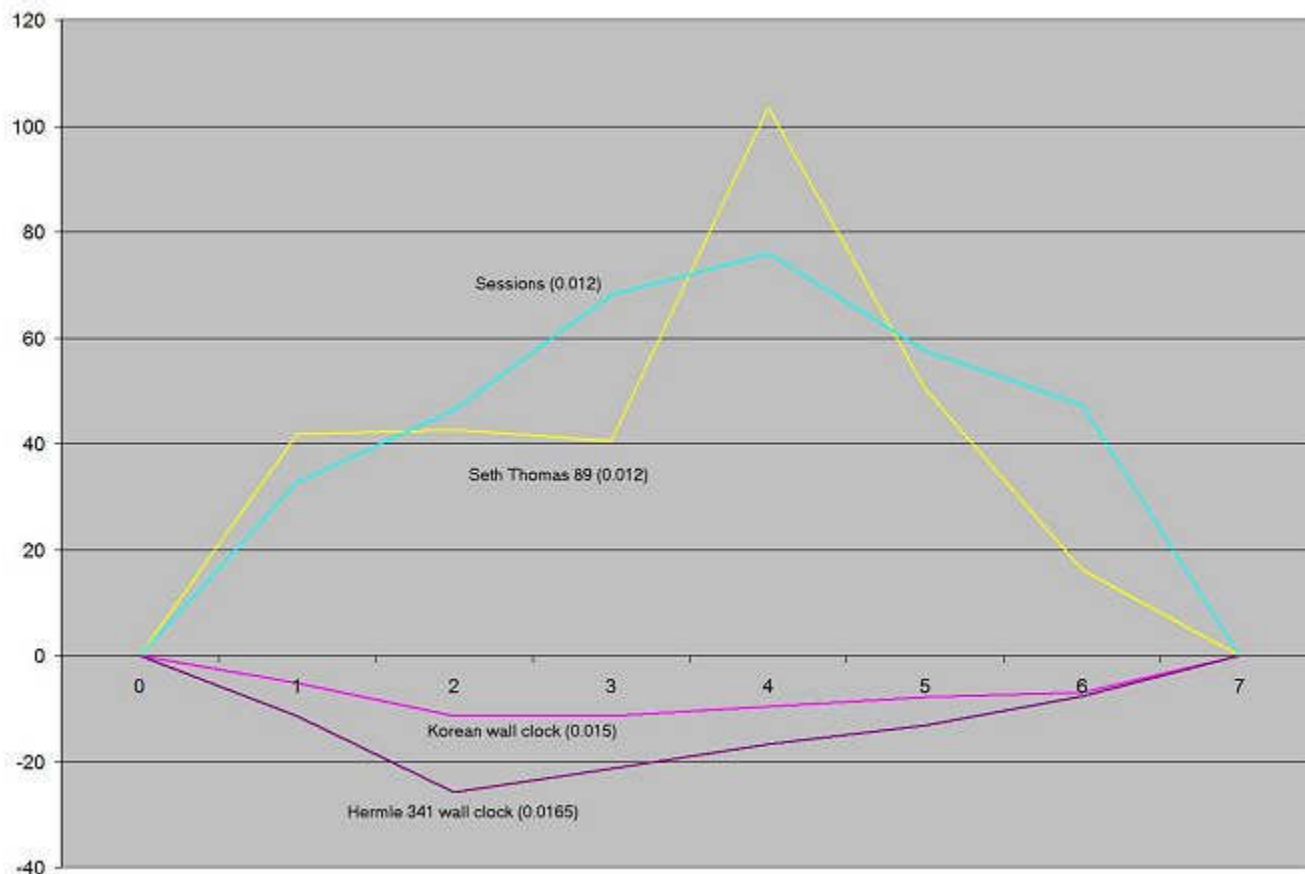
oriental clocks were designed by engineers and not clockmakers. The data confirmed my belief that the Korean clock would be more accurate. However, the data for the Seth Thomas 89 was somewhat irregular, revealing that the mainspring was not the best, so I included the data for two other clocks from my previous essay for comparison. On all the graphs, days one through seven are shown on the horizontal line (X axis). The timekeeping error in seconds is shown on the vertical line (Y axis). Click on each image to see the graph in full size.

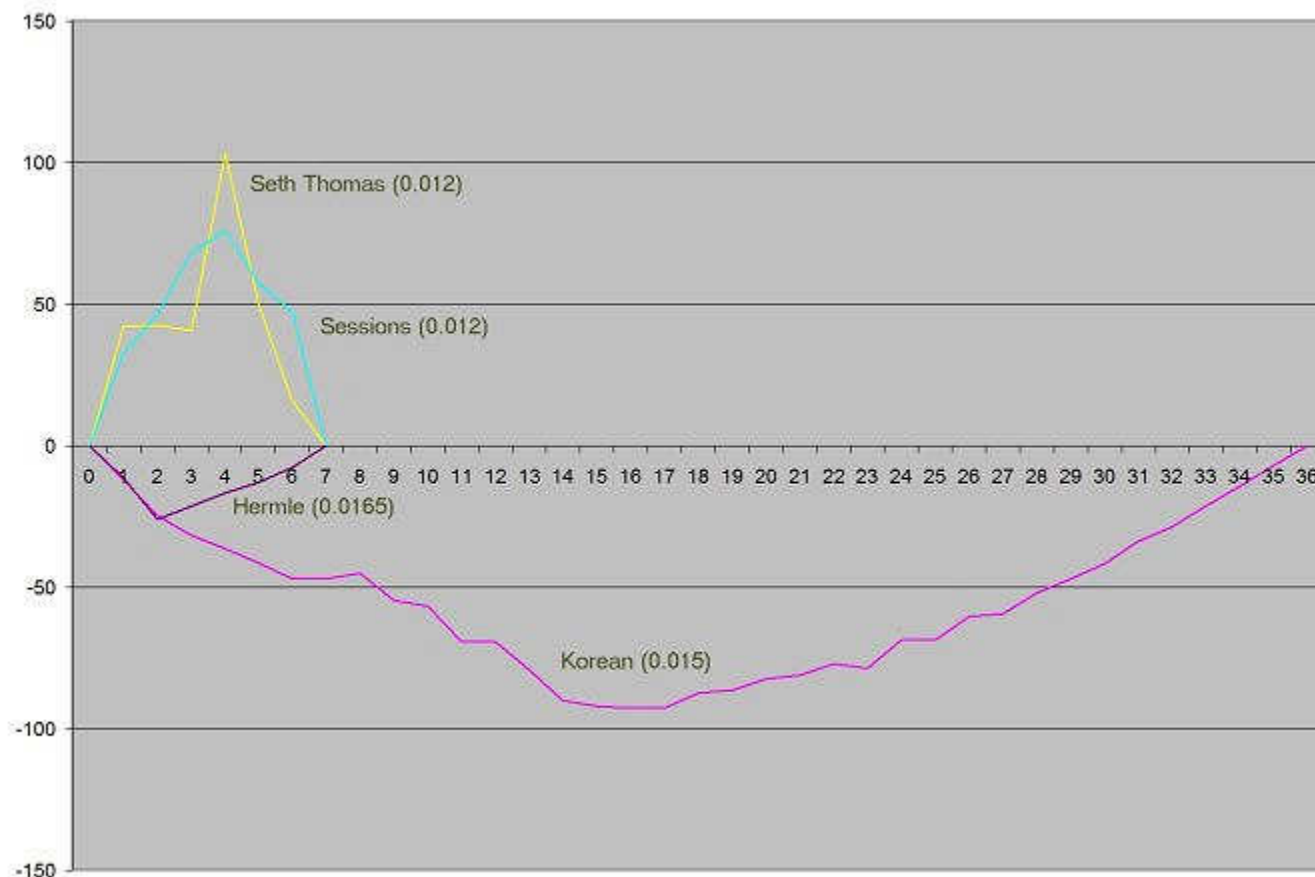
There was more to learn by continuing the test. This clock ran for 36.5 days, and the graph looked like the one below. After six days, the mainspring begins to show modest irregularity. By the end of the month, we can see a curve that reaches a bottom after 15 days.

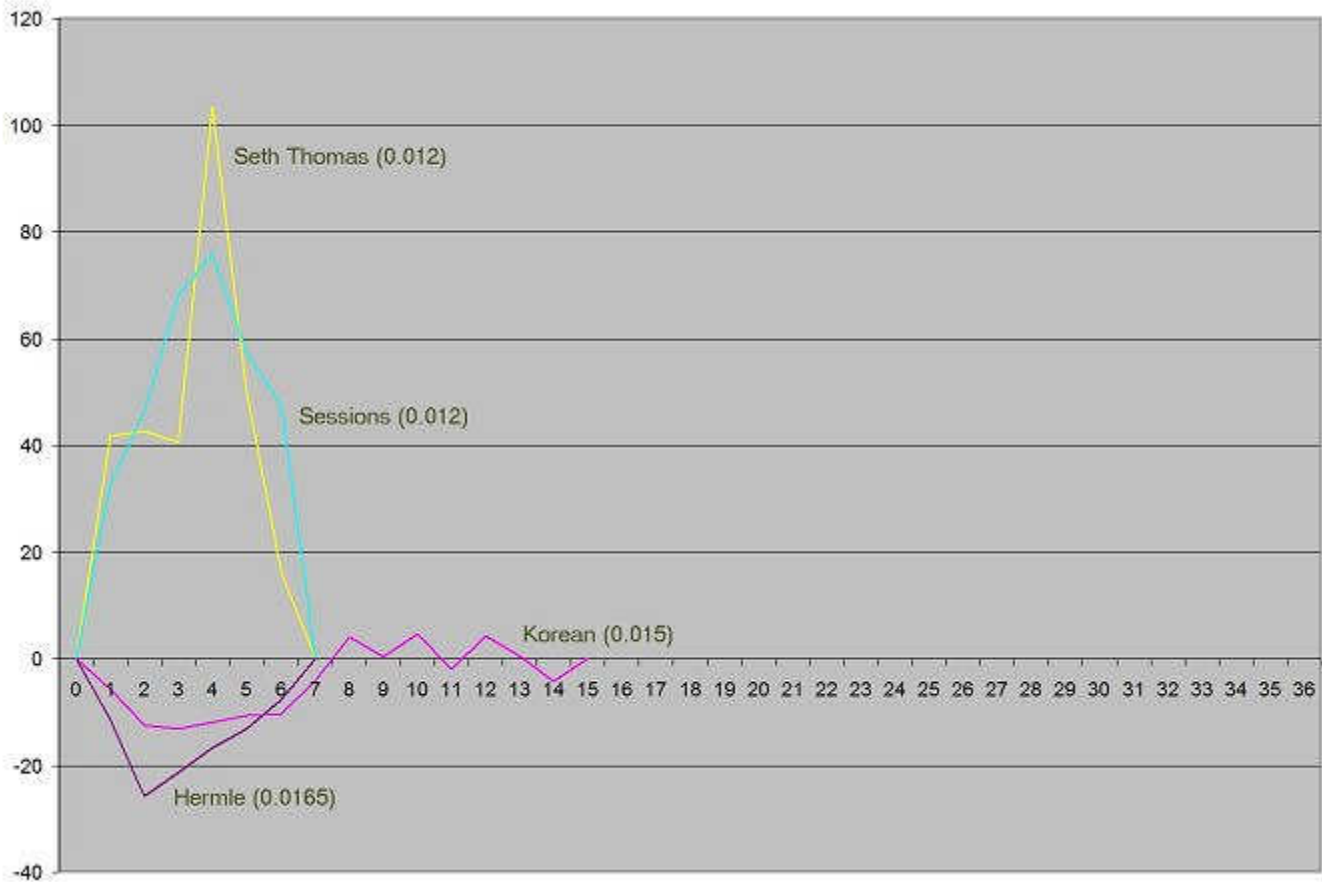
Considering a normal 31 day run, an overall error of 75 seconds over 31 days is very respectable for a spring-driven clock. This clock lost 5 seconds per day during the first half of the month, and gained 5 seconds per day during the second half of the month. Few clocks can match that performance. The clock could be made more accurate by winding it twice a month. The overall error would be reduced from 75 seconds to 13 seconds.

The data for the 31 day clock shows more clearly than for the other clocks how accuracy can be improved by winding the clock twice per cycle. If you have a clock which you wind once a day, wind it twice a day. If you have a clock which you wind once a week, wind it twice a week. If you have a clock which you wind once a month, wind it twice a month. Every time you wind your clock, move the minute hand a minute or two to the correct time.

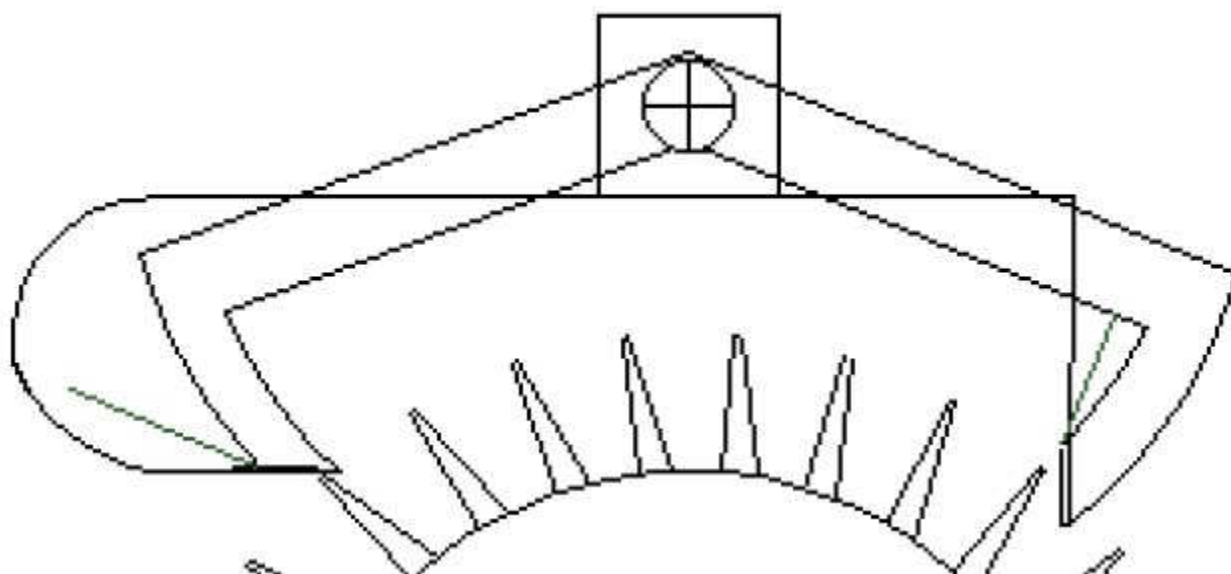
The image below has the recoil escapement superimposed over the Graham escapement with an added line on each side to show a possible locking face for a Graham escapement with some recoil.

Since a clock gained more time with the recoil escapement than a clock lost with the Graham escapement in the first half of the cycle, an angle of less than 22° would be needed, such as 10 or 15° . As shown in my previous essay, using a stronger mainspring affected the accuracy of both the recoil and the Graham escapements, so the optimal angle of the locking face on the Graham escapement would also depend upon the strength of the mainspring. Using a stronger mainspring would require a smaller angle for the locking face.

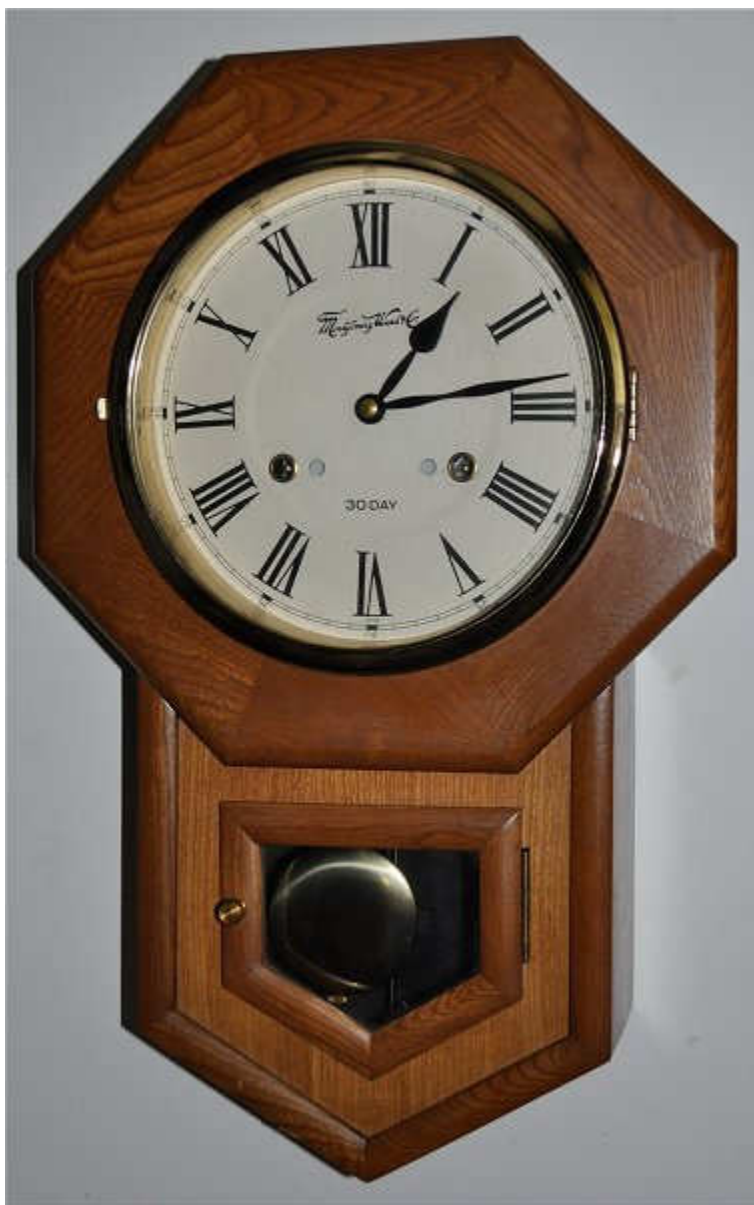
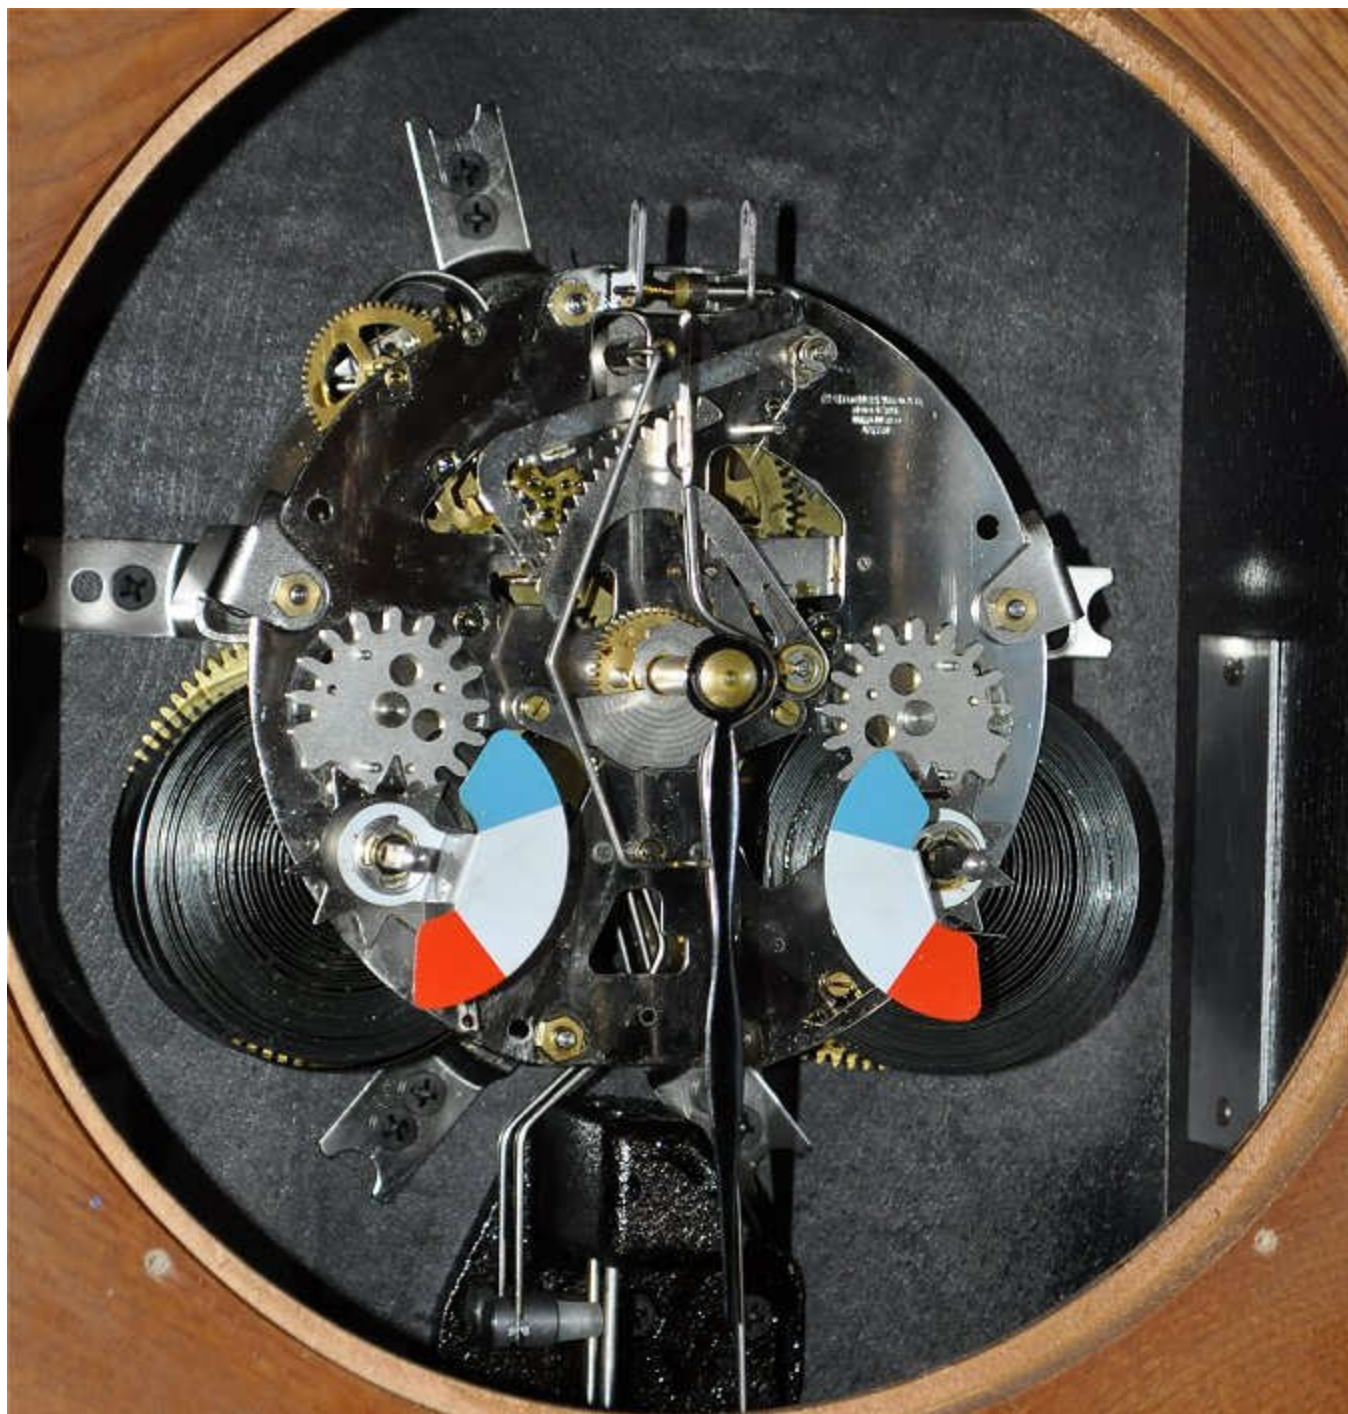
And now, finally, a Montgomery Ward clock made in Japan! This clock has stopworks and wind indicators, and appears to be chrome plated. It is a high-mileage clock with a lot of wear, having served its owner reliably for many, many years. It was probably made in the late 1960s.

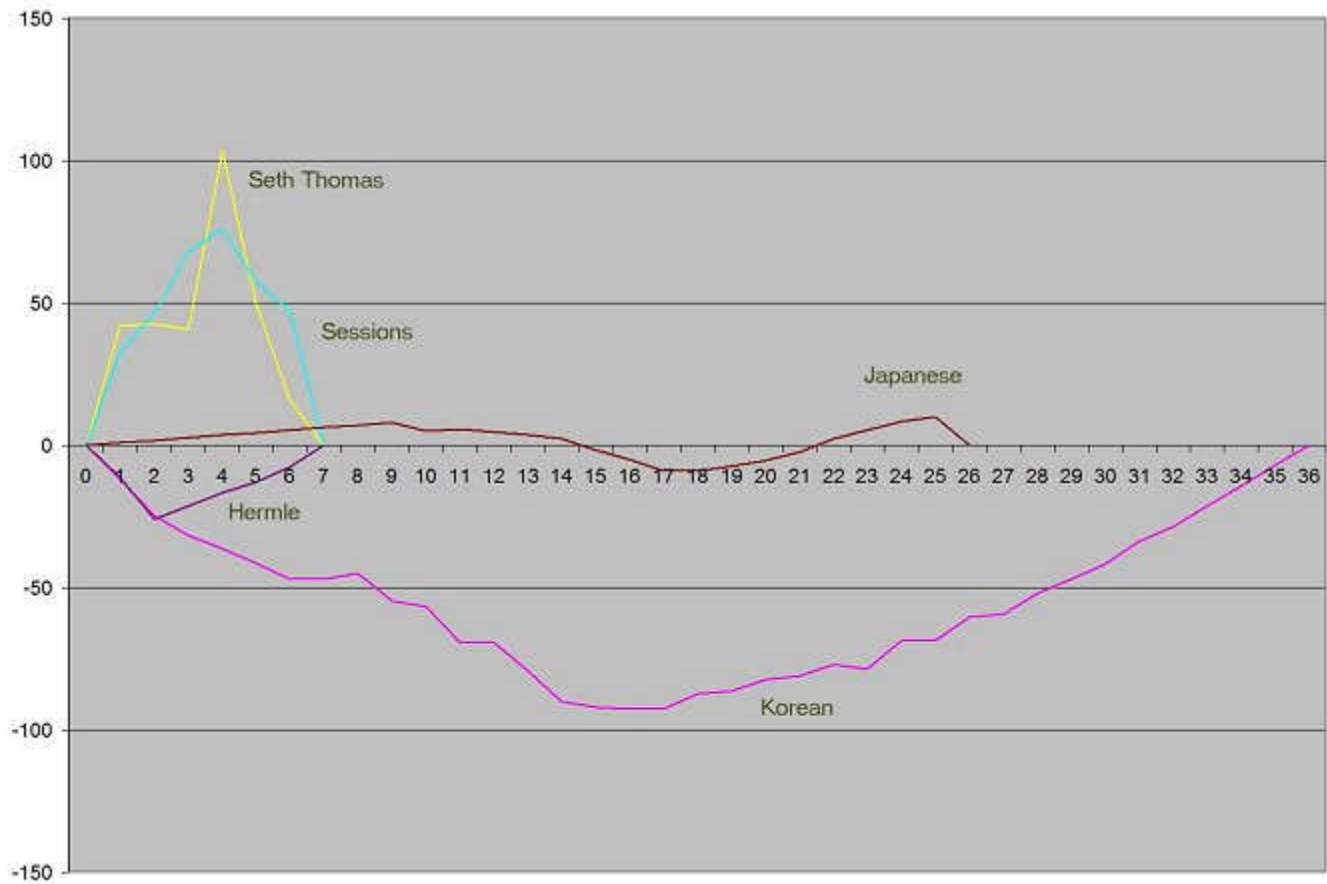
The Japanese clock stopped after 26 days.

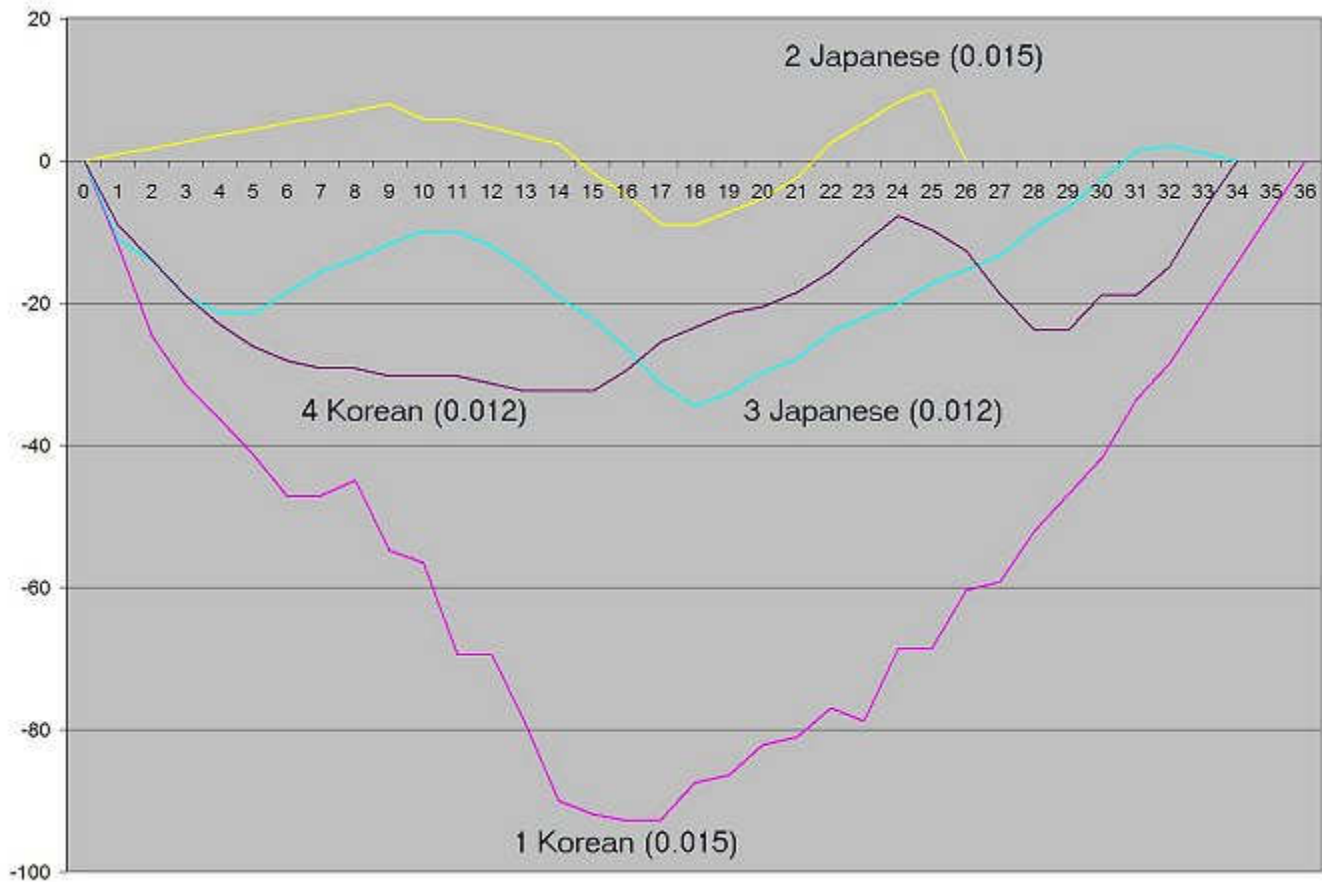
Update: The new replacement mainspring showed a similar curve, reaching a bottom on the 18th day, comparing lines 2 and 3 in the graph below, suggesting that the variation was more likely caused by the escapement instead, possibly in a longer term trend line. Whereas the old mainspring was 0.015" thick and 170" long, the new mainspring was 0.012" thick, with only half the strength, and was only 70" long. I decided to try it because my spreadsheet for mainsprings calculated that I would get almost 26 turns with the old mainspring, and 23 turns with the new one, so the difference would be small. I polished the pivots of the escape wheel and the fourth wheel, replaced the mainsprings and one bushing. The Japanese clock ran for 34 days with the new mainsprings, (though the strike stopped after 25 days).

With the new mainsprings, the Japanese clock had a maximum variable error of 35 seconds on the 18th day, shown in line 3, or a variable error of about 2 seconds per day. Between the 18th day and the 30th day, the clock gained about 3 seconds per day. Line 4 shows the performance for the Korean clock with new 0.012" mainsprings, which raises more questions than answers because it is more similar to the lines for the Japanese clock rather than Line 1. The data show that by lowering the mainspring strength by 50% will lower the variable error in the timekeeping by at least 50%. Furthermore, the duration of up to 36 days is not affected by the mainspring length by much, shown by replacing a 170" long spring with a 70" long spring. The duration is much more affected by the size of the mainspring barrel, or the amount of space the spring has available to expand in. The photo below shows the Korean clock with the new 0.012" mainsprings. The strike mainspring is fully wound, and barely visible. I left the time mainspring unwound for the photo, so that you could see it.
